**KERALA AGRICULTURAL UNIVERSITY  
COLLEGE OF HORTICULTURE**

**“PUNARJANI”**

**Citizens survey report**

of Wadakkanchery river, done as part of Rural  
Agricultural Work Experience Program

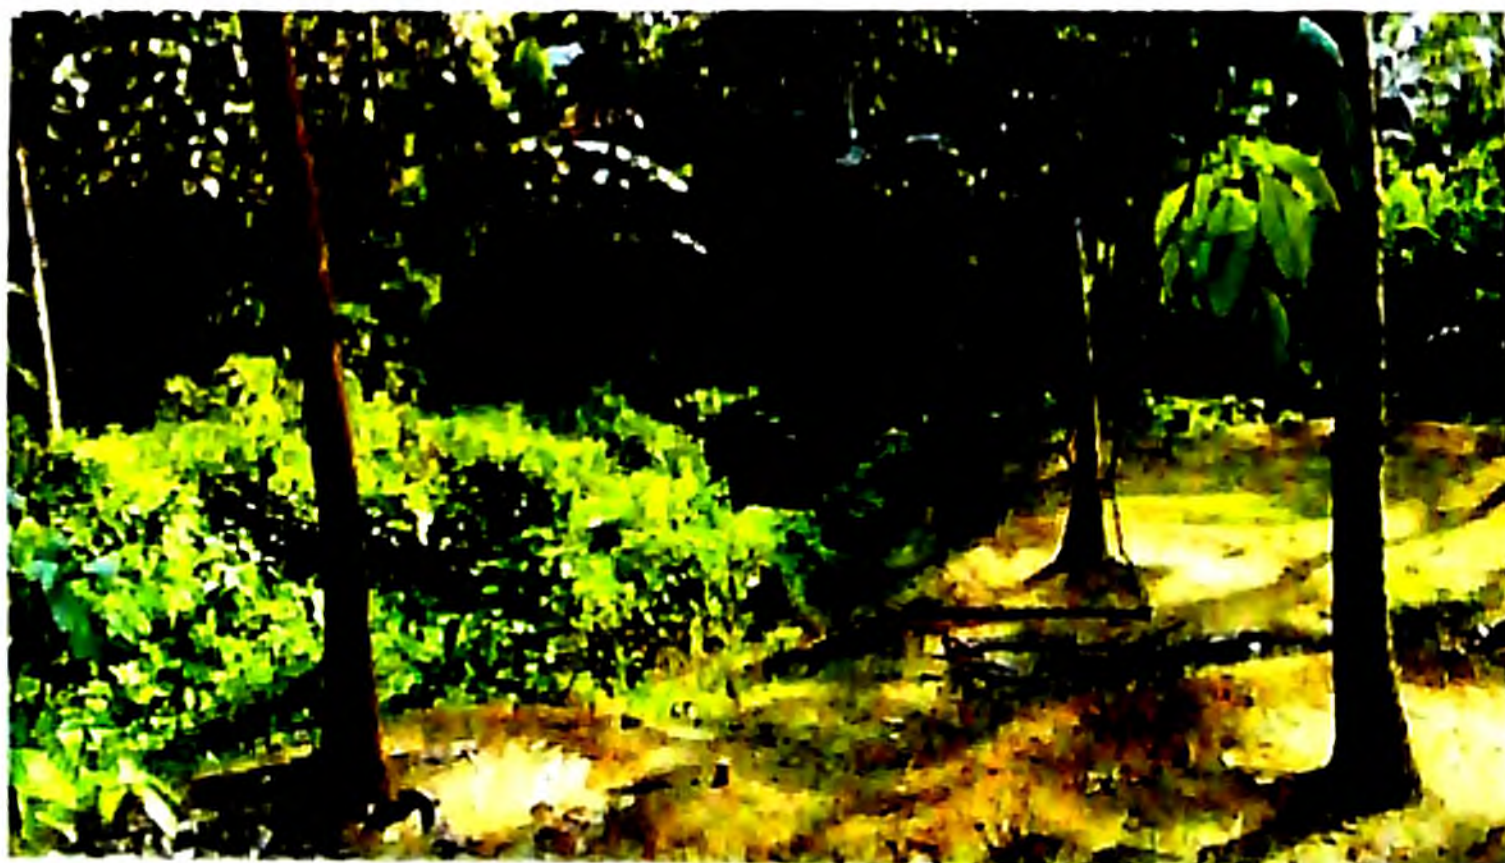
Encroached portions of the stream

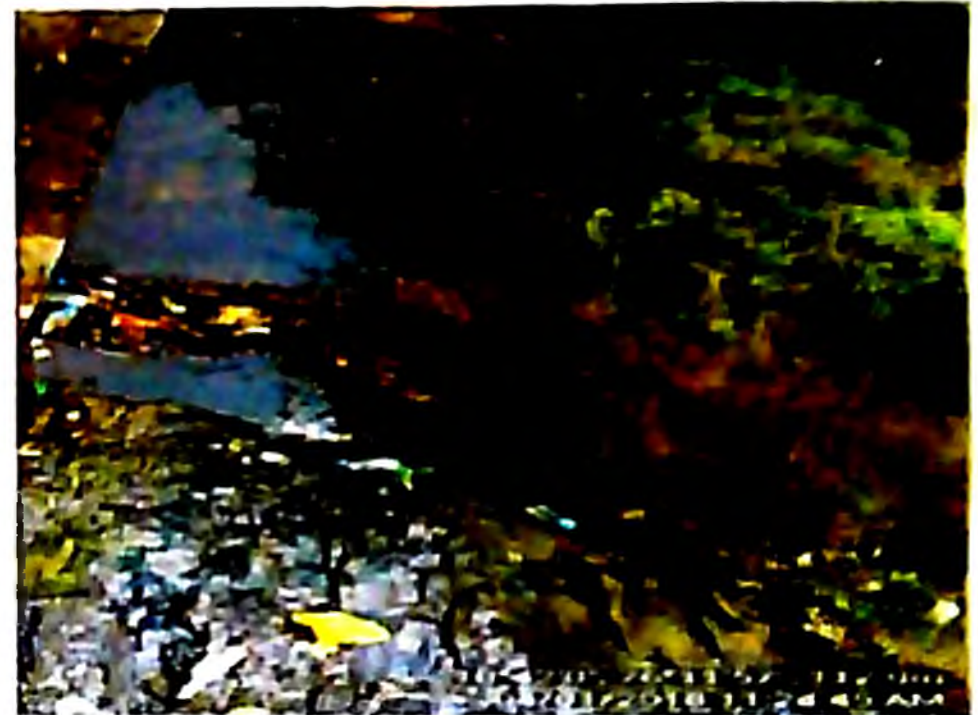
Waste dumping near  
Cheruchakkichola dam

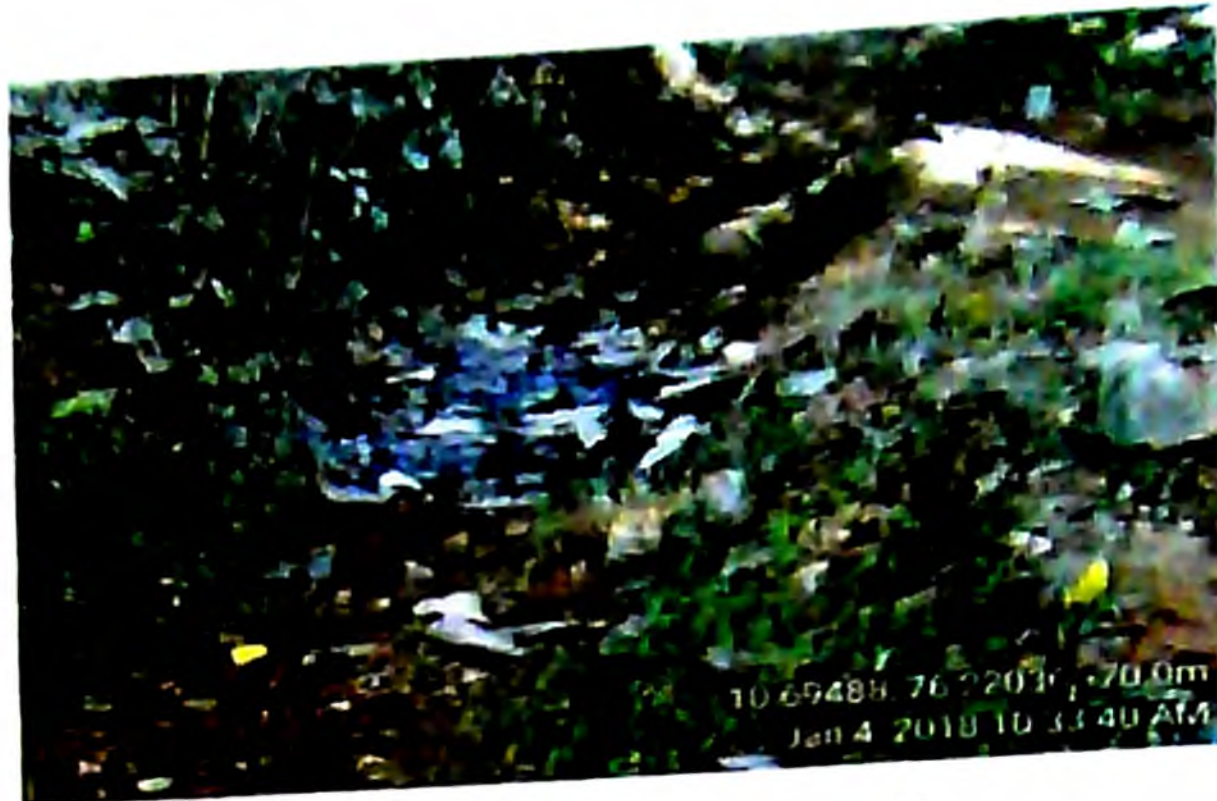
Remnants of burned wastes

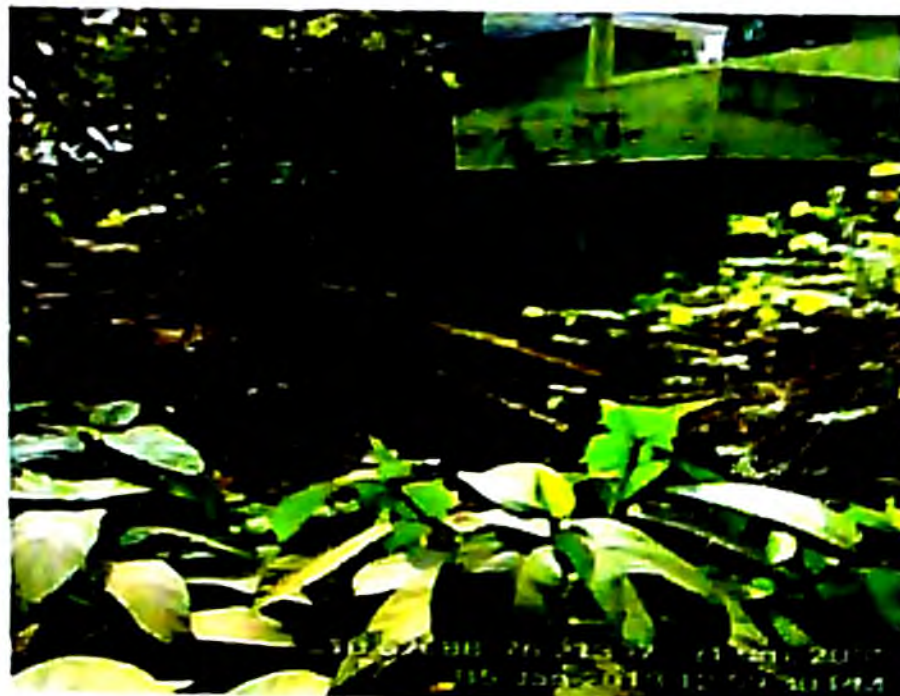
Waste water is deposited to the stream through pipes

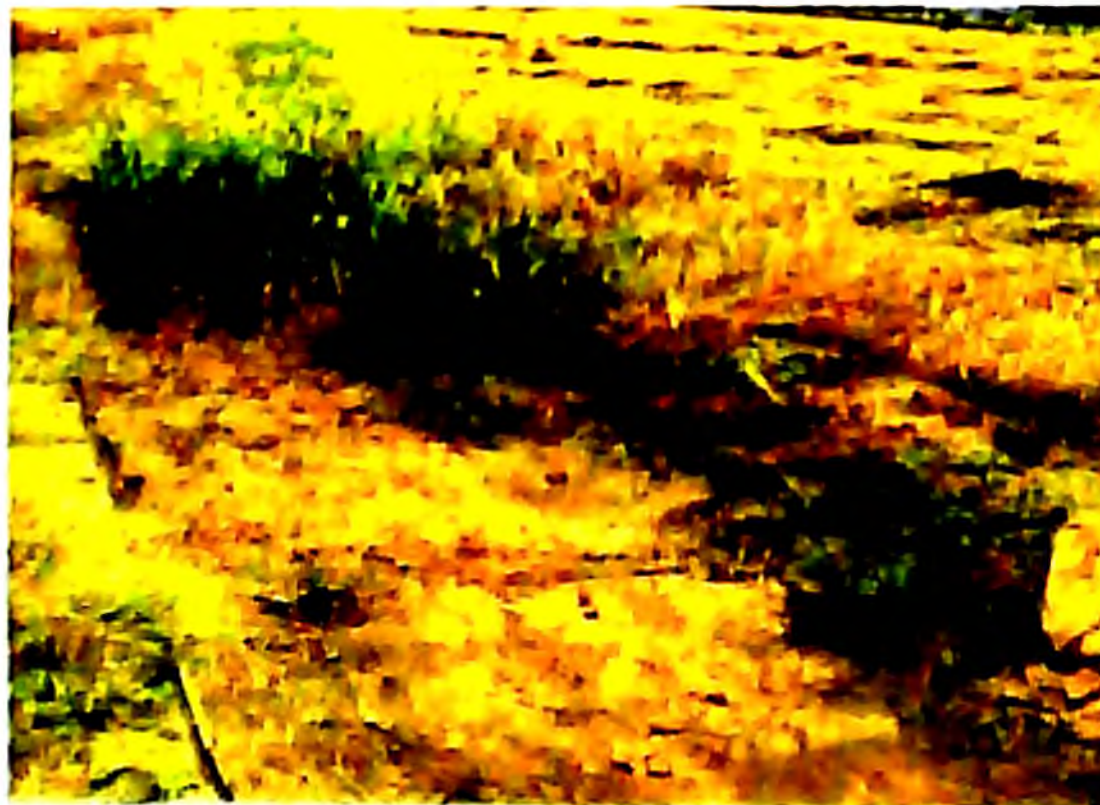
Rice is cultivated in the stream

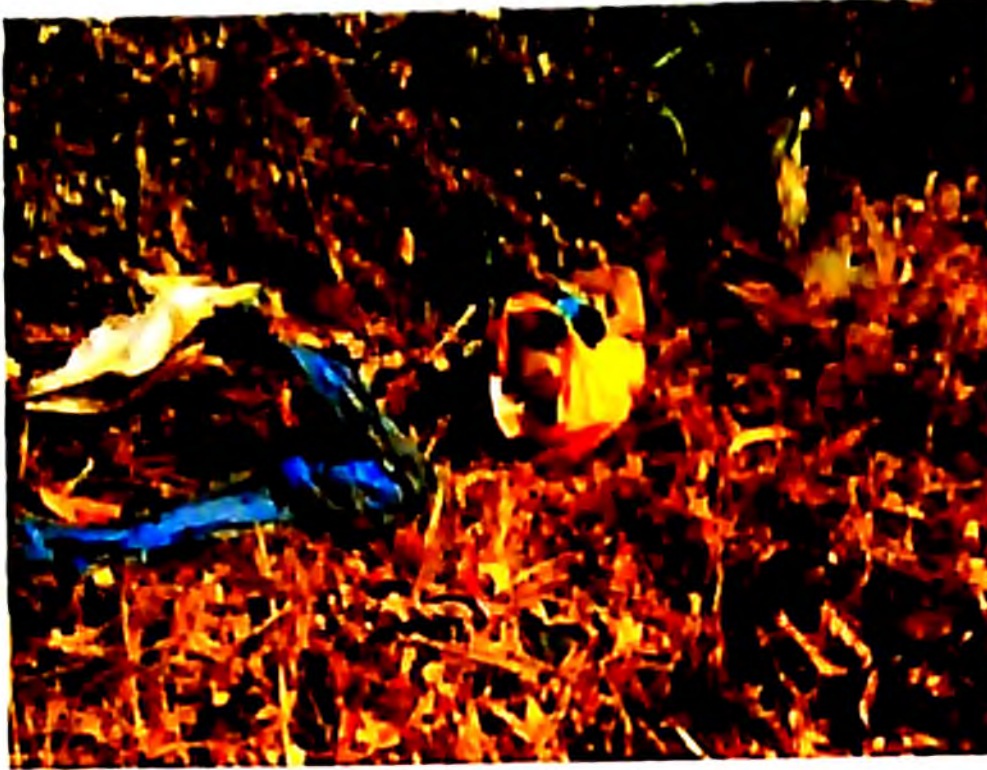
Plastic wastes are dumped into the stream

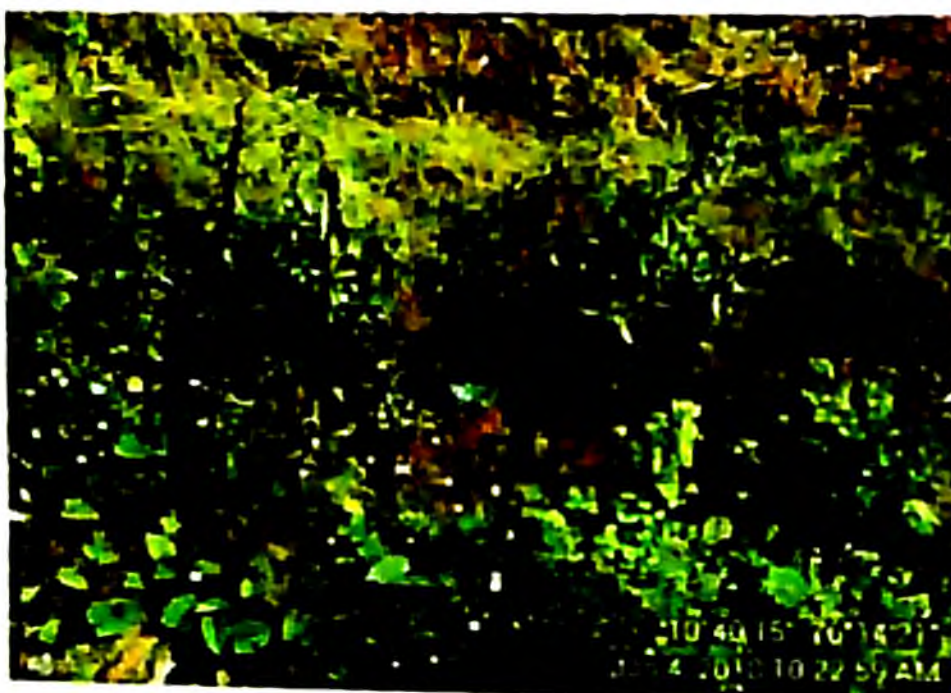
The covers of pesticide

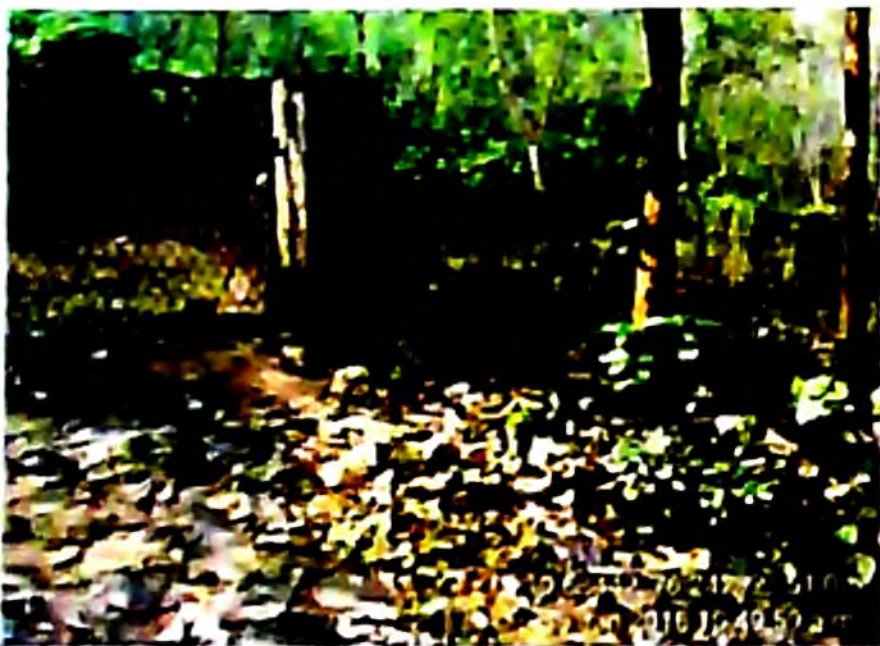
Rubber plantation instead of stream

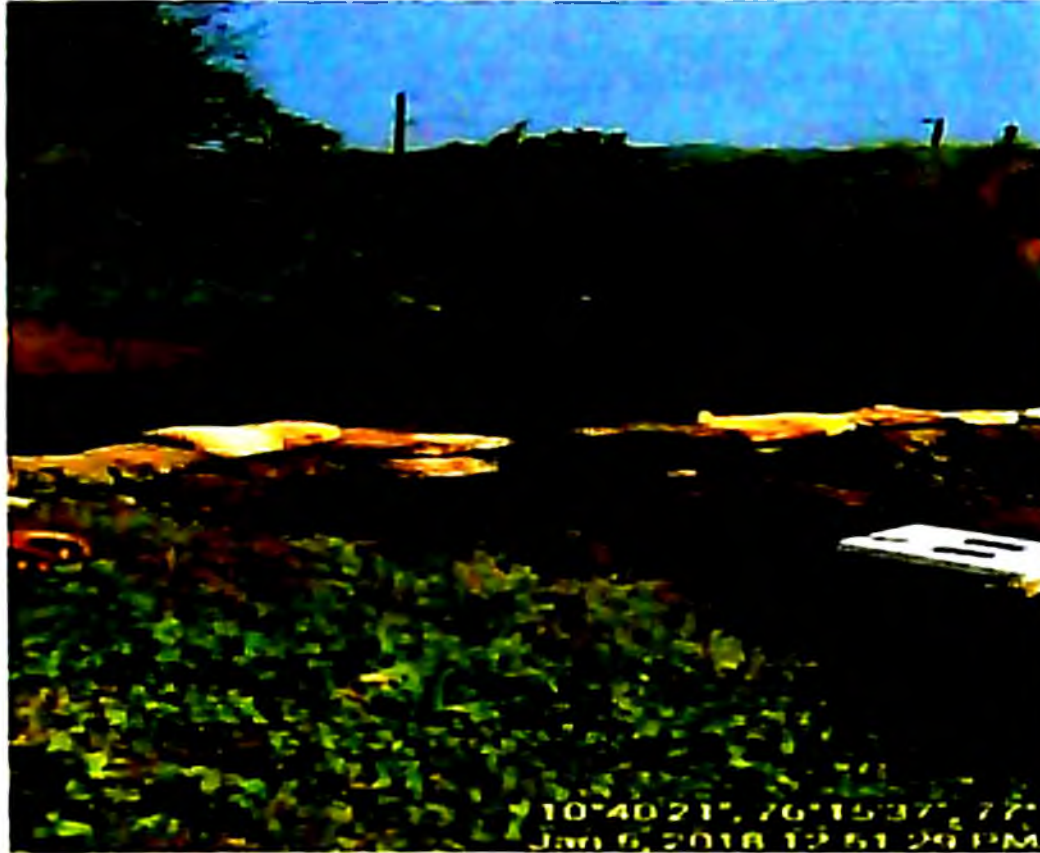
Water flow blocked using sand bag

- Avoid disposing wastes in the stream
- Protect both sides of the stream
- Construct bunds across the stream for water infiltration

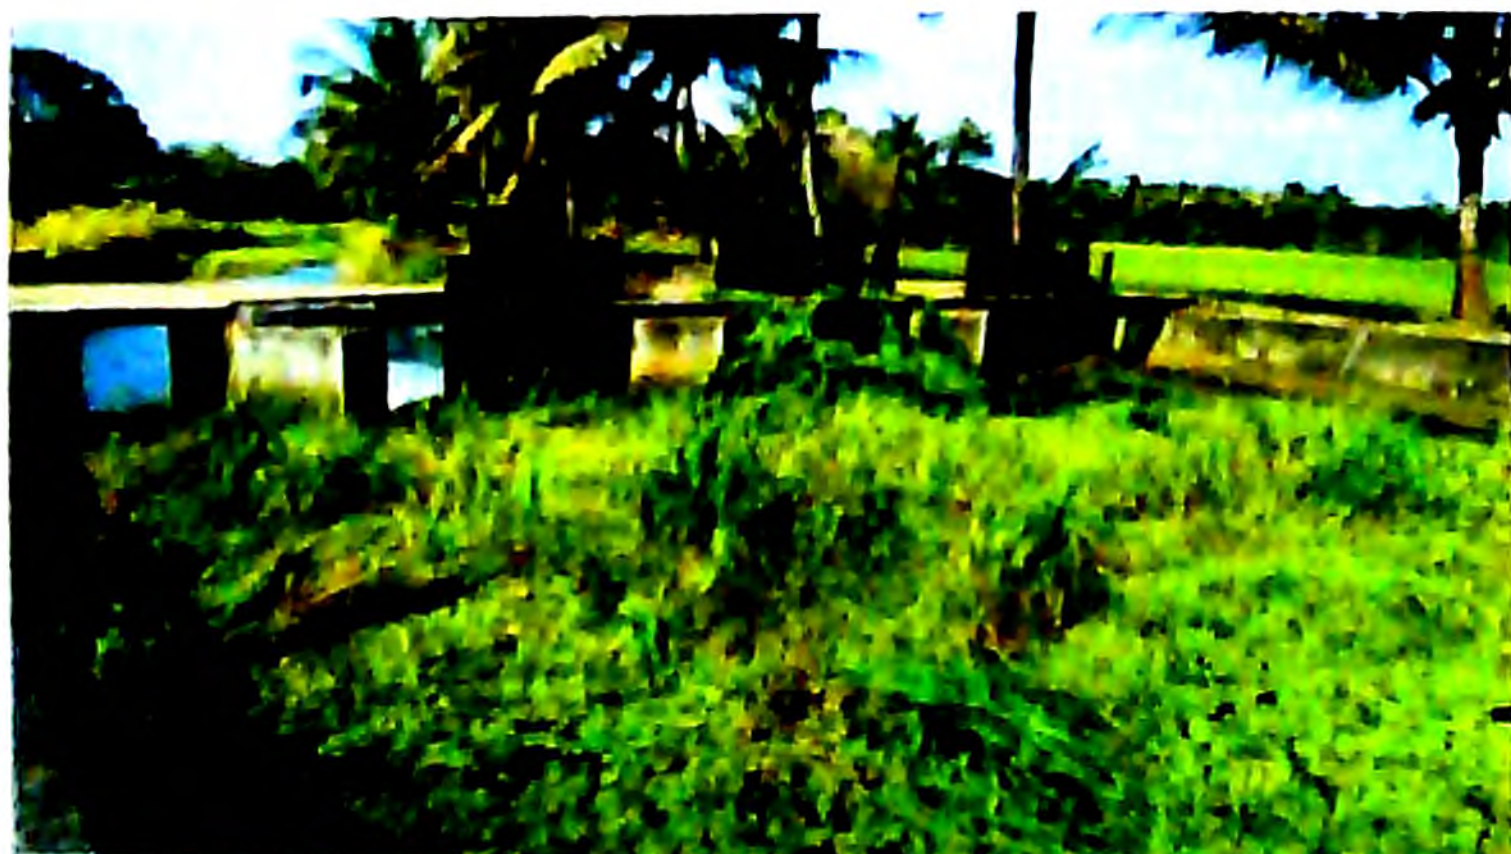
Menace of *Salvinia molesta* growth

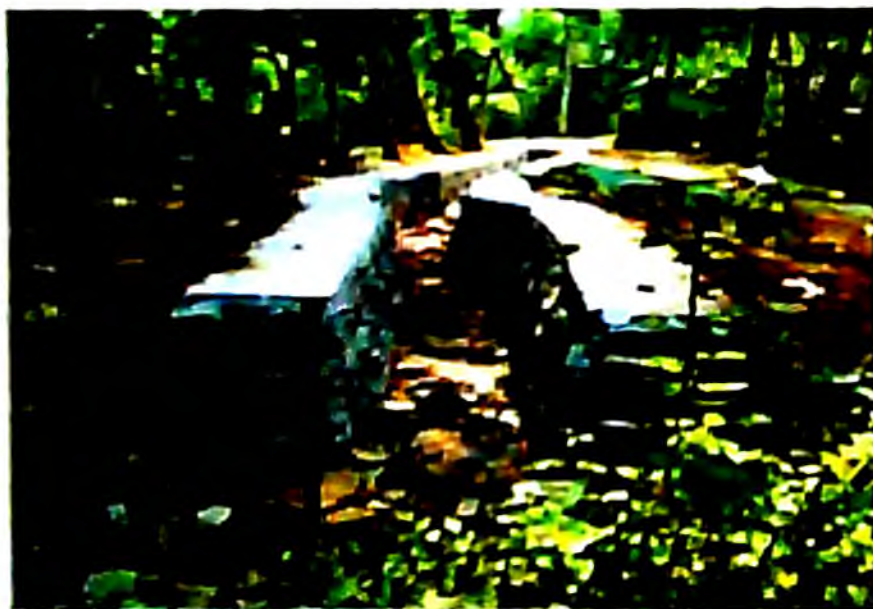
Encroachment of water channels with private walls

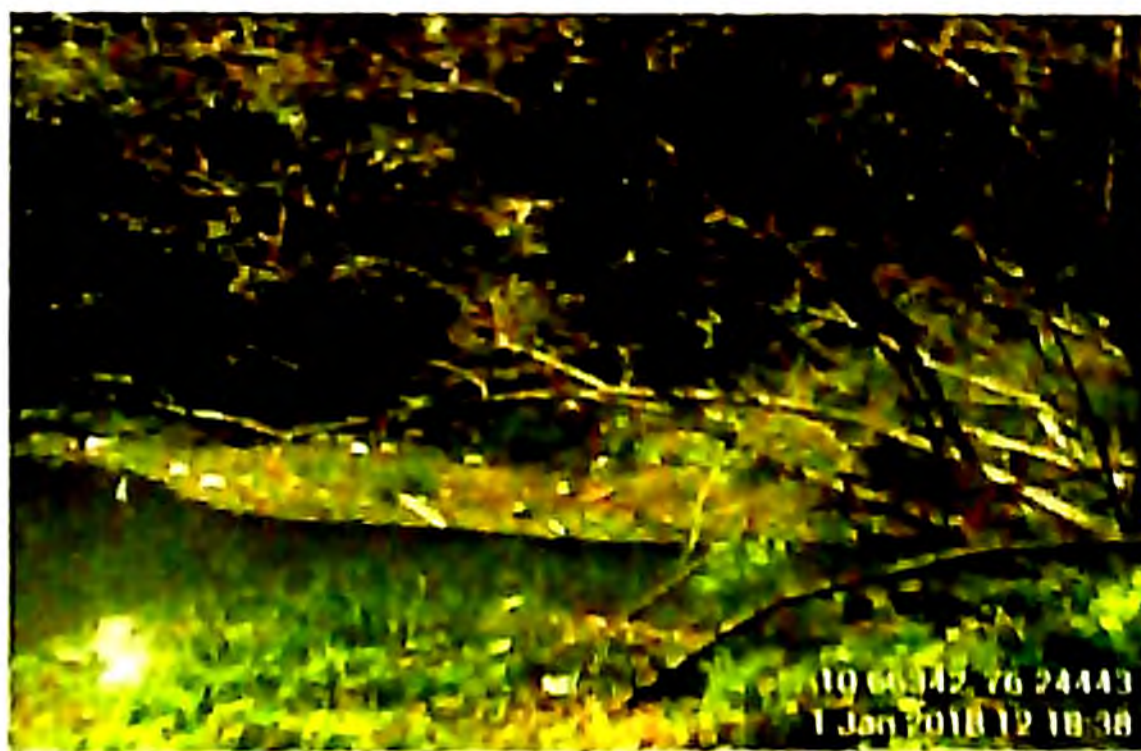
Accumulation of plastic wastes in the river

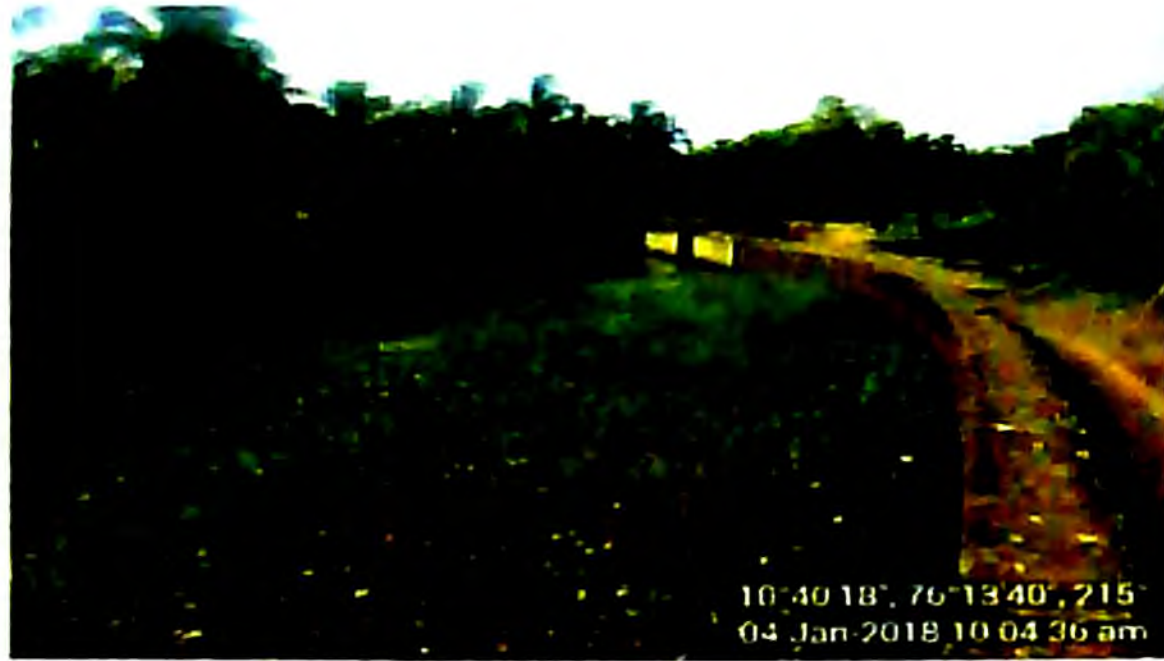
River filled with aquatic weeds

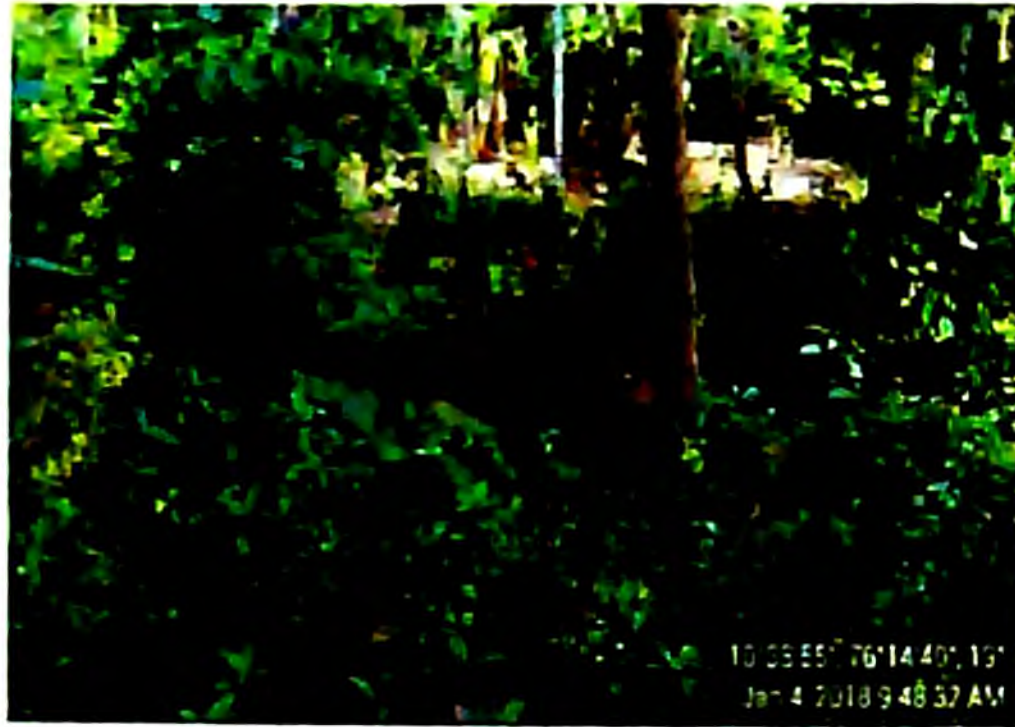
Converted river area for cultivation of plantation crops

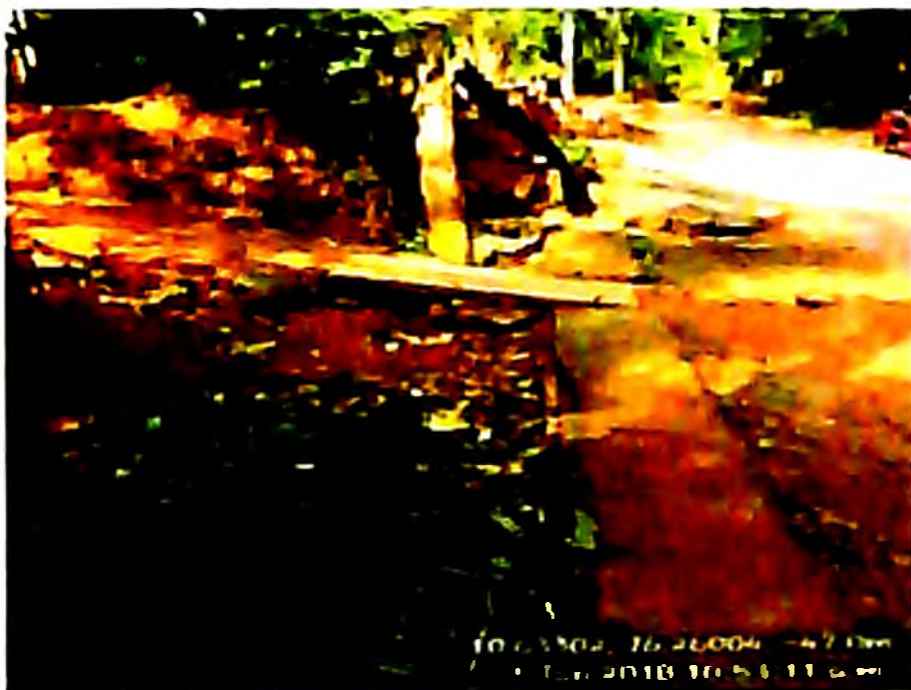
The condition of channels near the colony

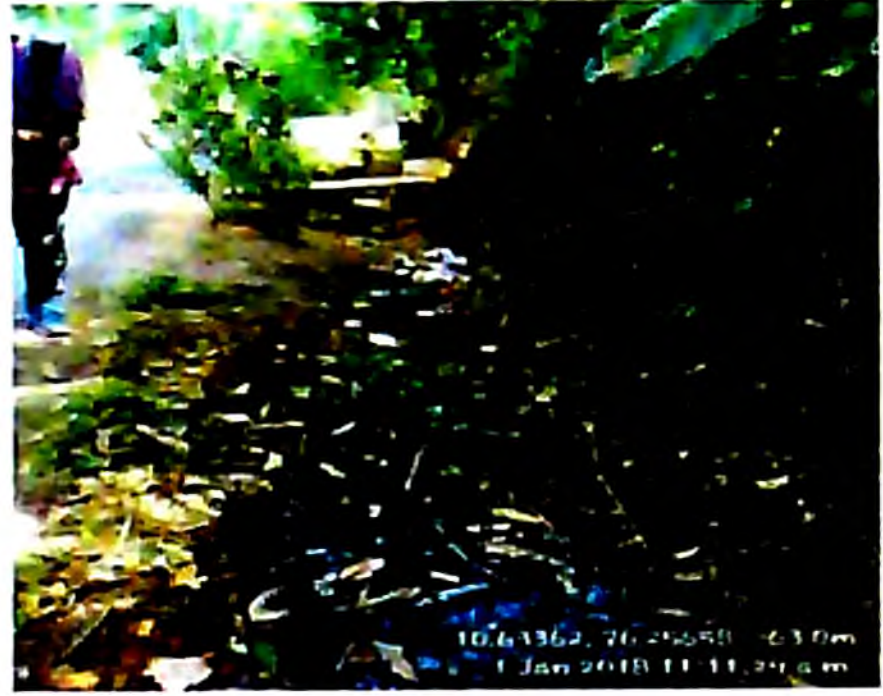
Burning of litter

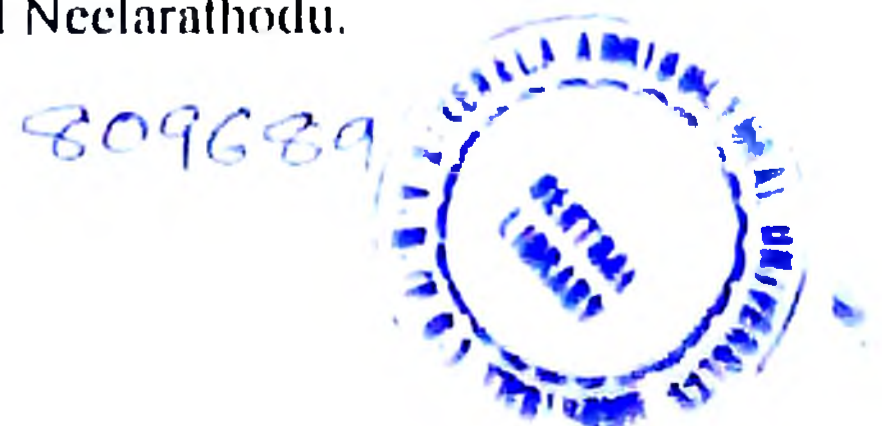
Waste disposal.

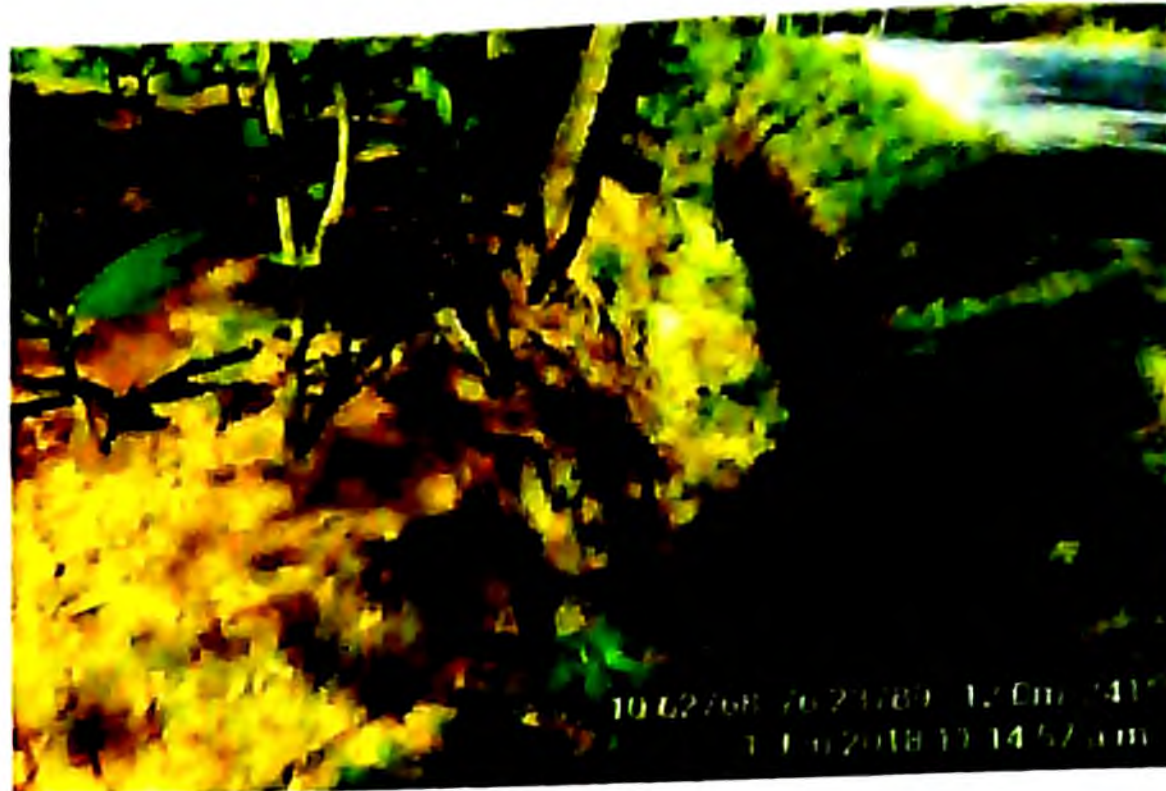
The stream seems to be dried

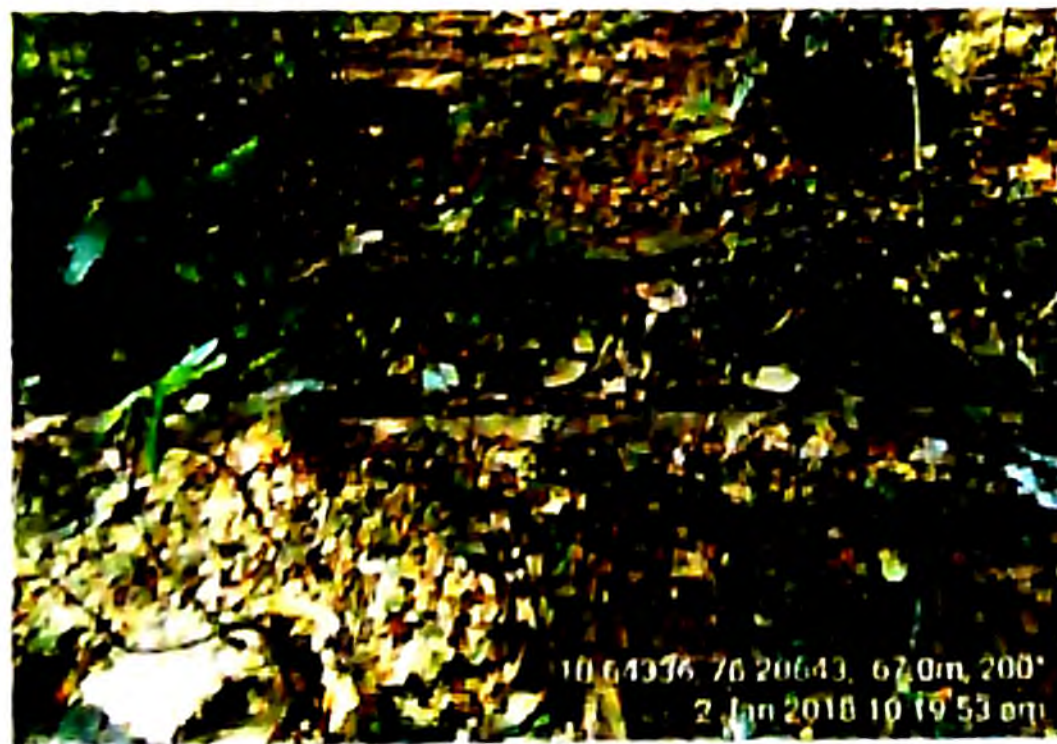
Stream in which there is no flow for the last 30 years.

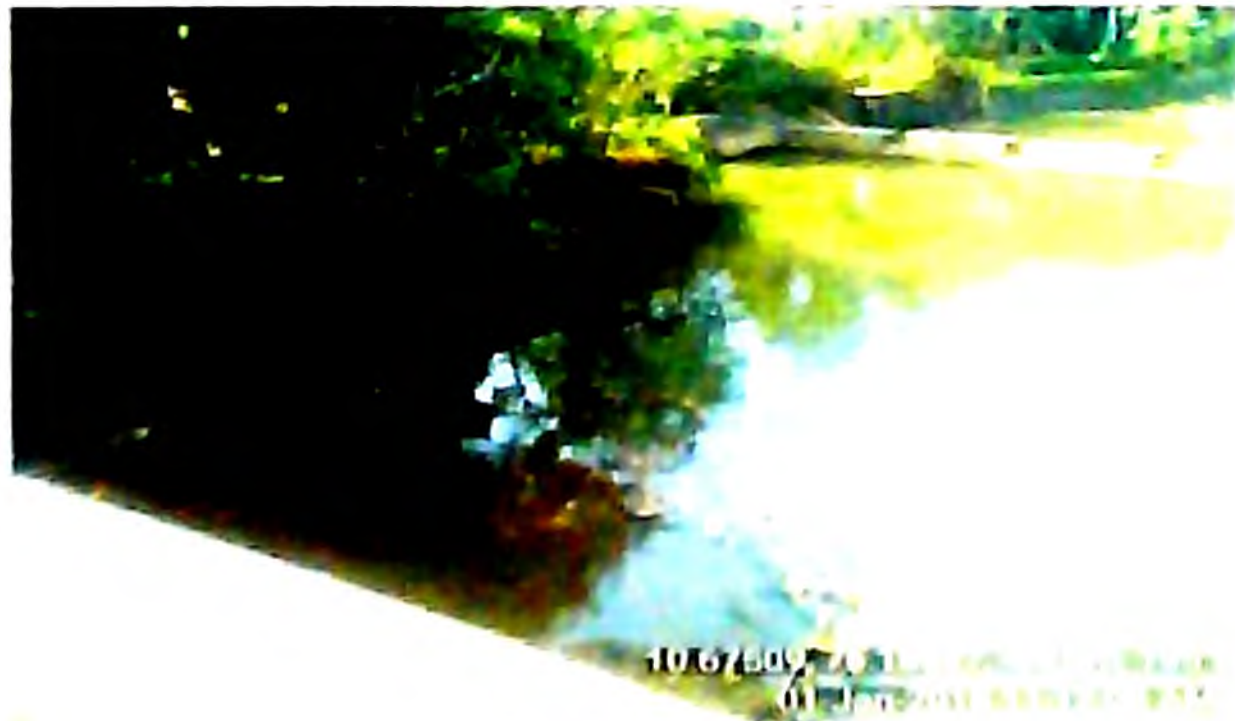
Wastes deposited in the stream

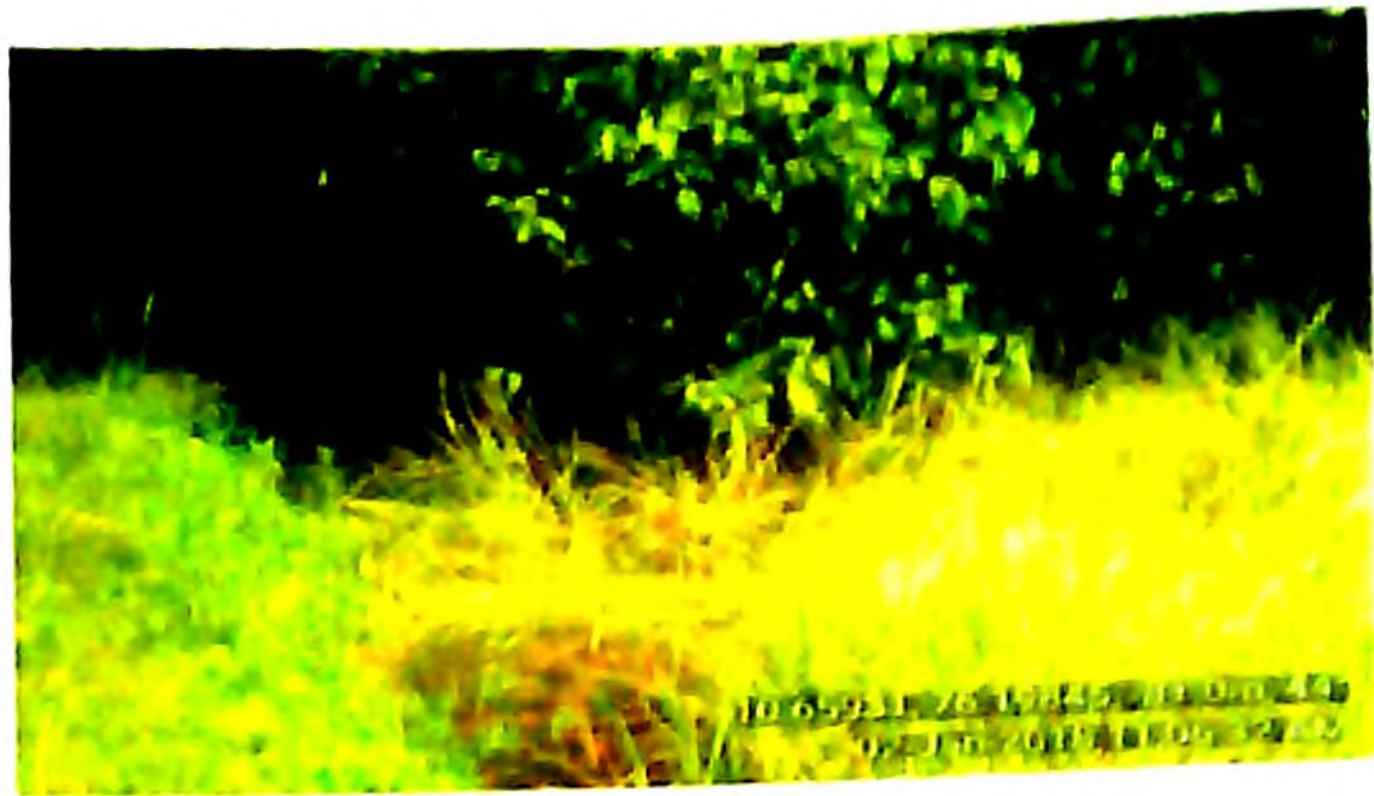
Polluted pond

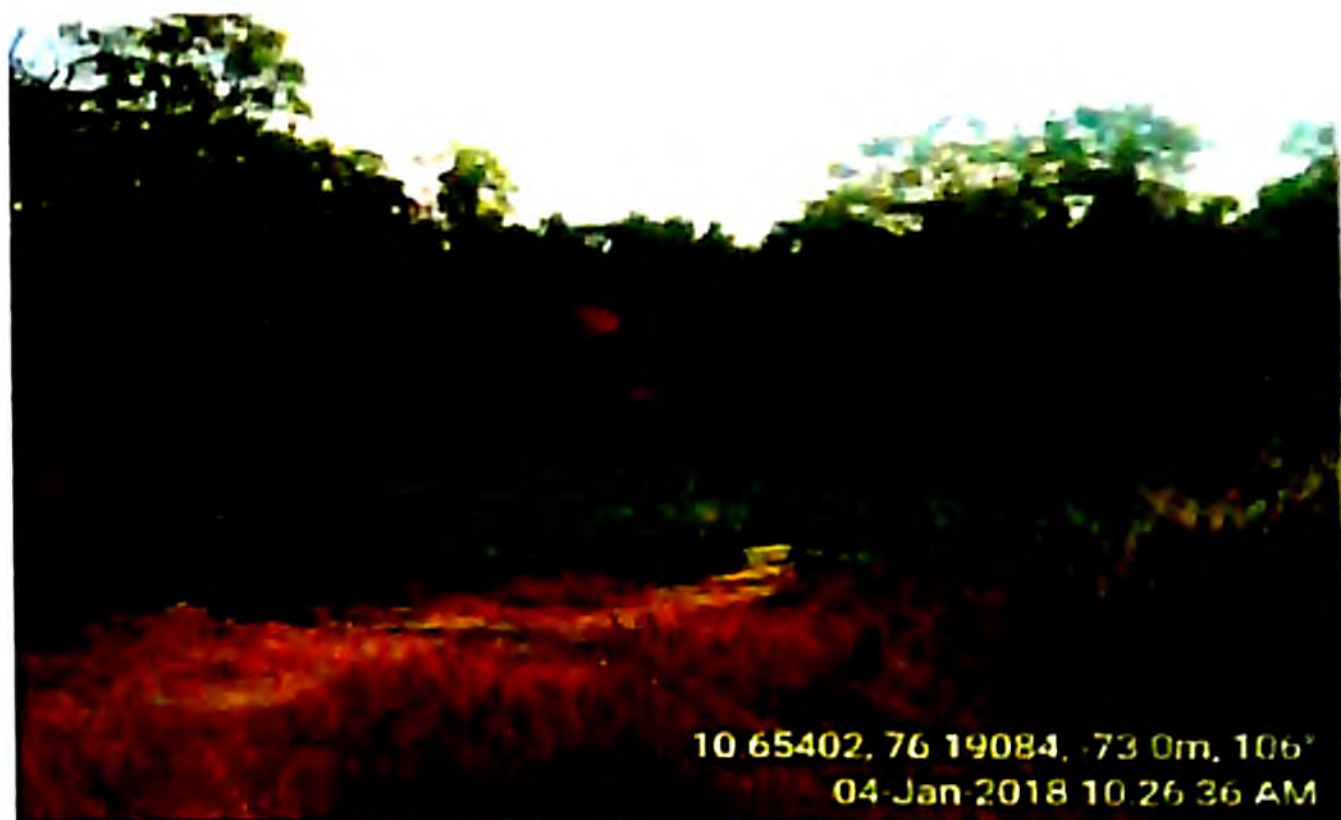
Pound contain salvinia

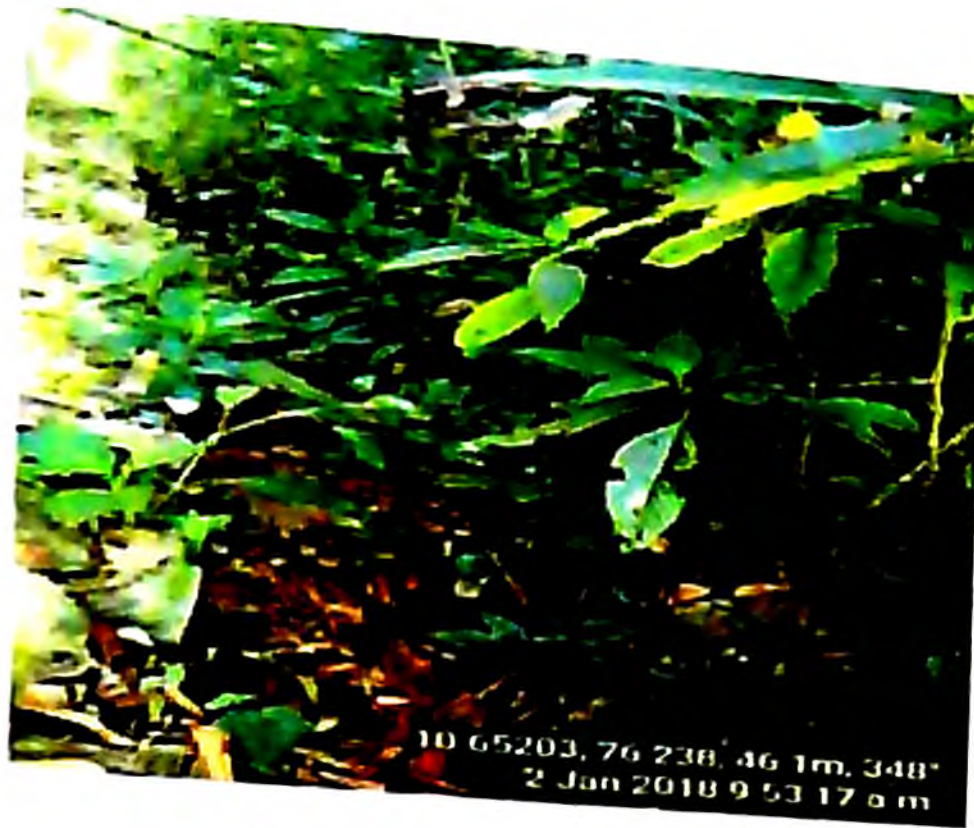
Discontinuous Stream

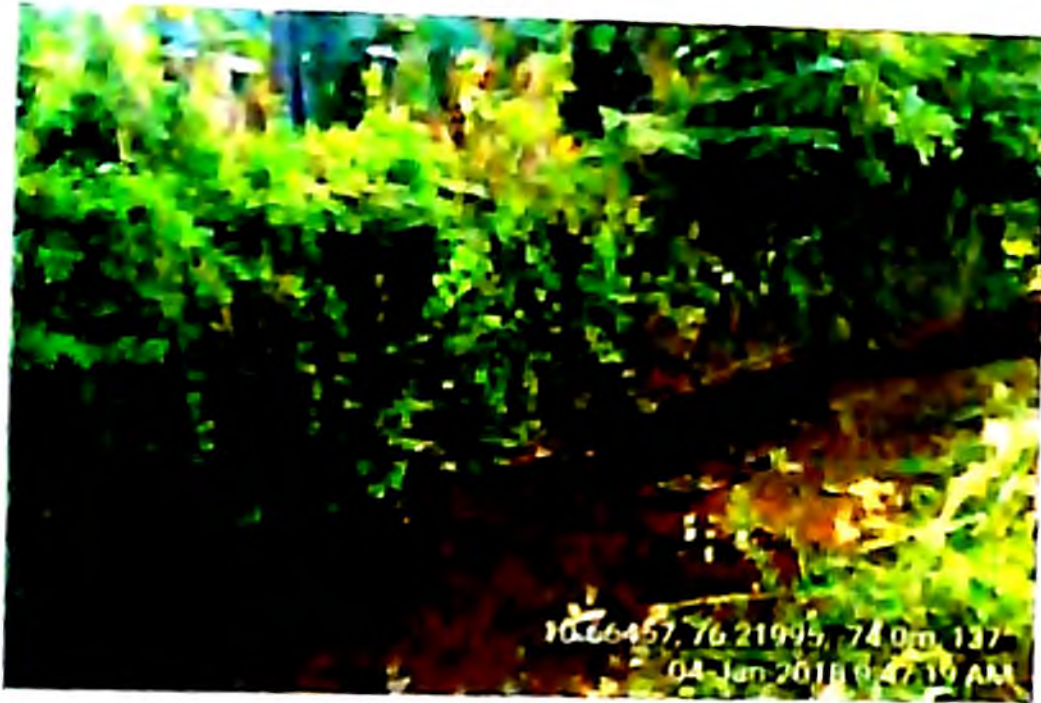
Siltation
