**ASSESSMENT OF THE IMPACT OF SAND MINING ON THE
MORPHOLOGY OF THE SEVERELY AFFECTED REACH OF
BHARATHAPUZHA RIVER BETWEEN PATTAMBI AND
KUTTIPPURAM USING REMOTE SENSING AND GIS**

THESIS

Master of Technology

(Soil and Water Engineering)

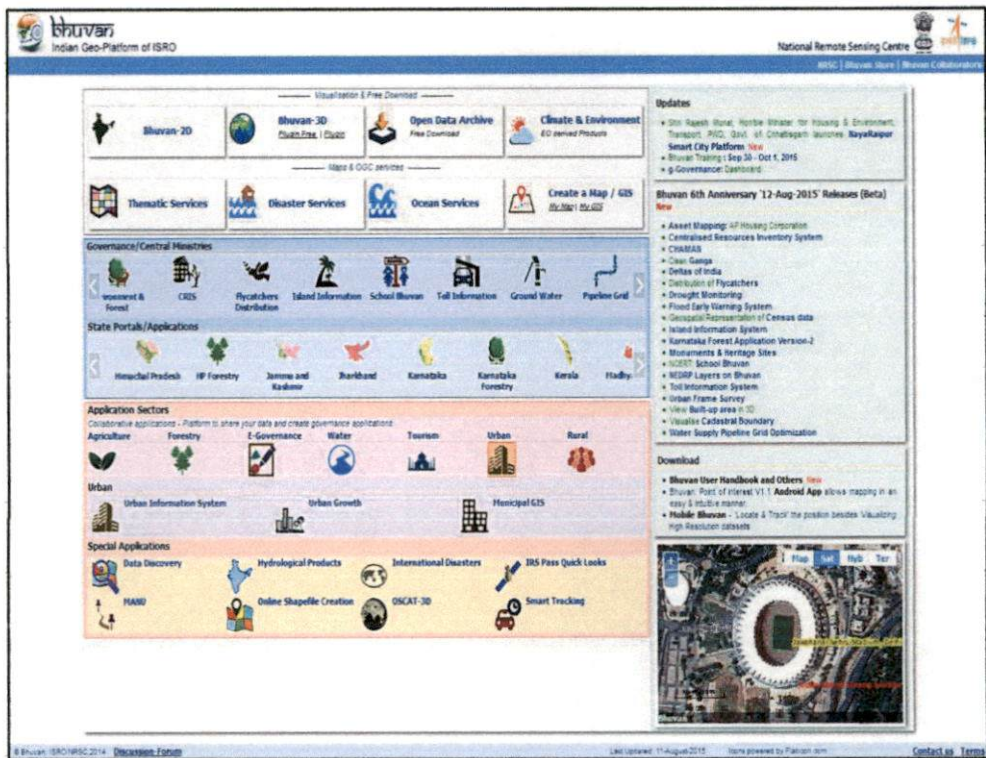
Fig. 3.7 Bhuvan user interface

Bhuvan is a Geoportal of Indian Space Research Organization (ISRO), hosted through URL <http://bhuvan.nrsc.gov.in>. with a host of wide ranging services that cover visualization of multi-date, multi-platform, multi-sensor satellite data, thematic map display, query and analysis, free data downloads and products, near real-time disaster services, apps for crowd sourcing and diverse geospatial applications. Bhuvan is the only government platform in India that is operational in public domain with PAN-India coverage of systematic geographical database. Fig. 3.7 shows the Bhuvan user interface. The platform allows seamless transitions from national to village level depiction of variety of geospatial datasets that are unique to Bhuvan. The platform not only enables good base data and image display up to 1m spatial resolution, but also provides hydrological base for the country from basin to watershed, transport network from national highways to city roads and rich location information. Apart from this, the scientifically derived Digital Surface

Model for entire country is another unique feature by Bhuvan that gives excellent depiction of the country's topography on the fly.

Bhuvan, as a platform, is open and being used by diverse user community. The Government agencies use this platform to share and host their data, as per their requirements, enabling specific applications of their choice. Bhuvan is used as a data and product clearing house for supporting scientific and Remote Sensing based projects. The data and products can be downloaded from NRSC/ISRO Open data and product archive. Requirement of users to carry out remote sensing based projects specially by universities, researchers and departments is fulfilled by providing free satellite data and products through NRSC Open Data Archives. Fig. 3.8 shows the data selection pane. With all these capabilities, today Bhuvan is reckoned as one of the most unique GIS platform of the country that is freely accessible on the internet used by wide varieties of user community including school children.

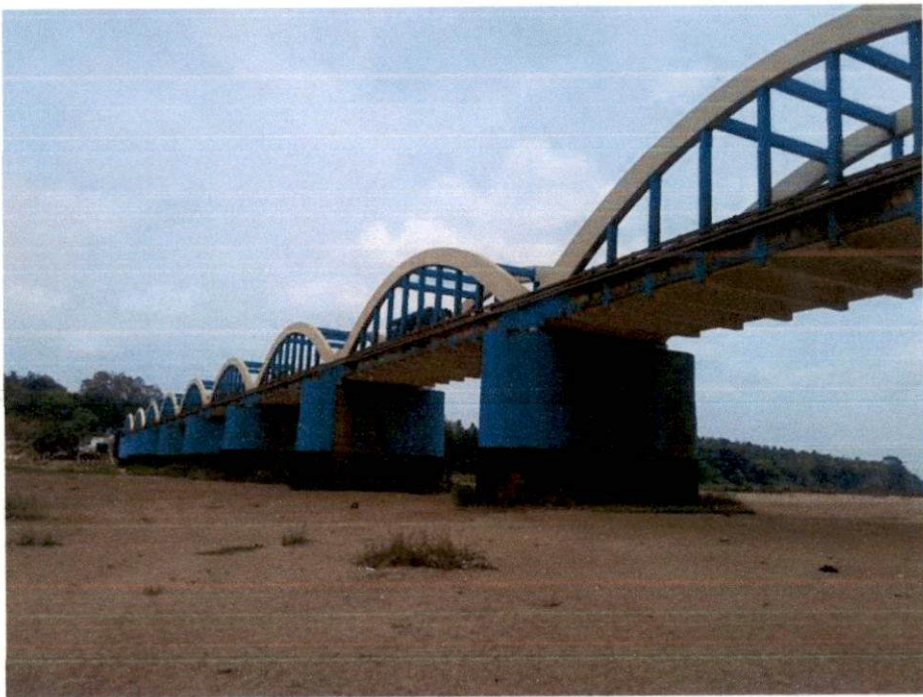
Plate 3.1 Mallur Kadavu

Total station survey at seven Kadavus which were accessible, were conducted to analyse the accuracy of the profile graph obtained using Elevation Profile add-in. Kadavus are places in the river reach where sand mining is a usual practice. Kadavus for survey were selected based on the areas with highest rate of mining. According to that the seven Kadavus selected were Vellanchery Kadavu, Nilayoram park, Mallur Kadvu, Kattadi Kadavu, Keltron Kadavu, Ummathur Ambala Kadavu and Kumbidi Ner Kadavu. Table 3.1 and Fig. 3.9 shows the location details of the seven Kadavus. Plates 3.1 and 3.2 represent the Mallur Kadavu and Vellanchery Kadavu. Total station survey was conducted in three sections at 30 m interval in each Kadavu. A total of 21 sections were surveyed. Data was collected from the accessible points only which forms only a representative portion in the actual cross section. According to the data obtained from the field a cross section profile graph for the seven Kadavus were drawn. Similarly, cross-section lines representing these sections at each Kadavu were drawn in the latest DEM available from Bhuvan and cross profiles were generated. The cross-section

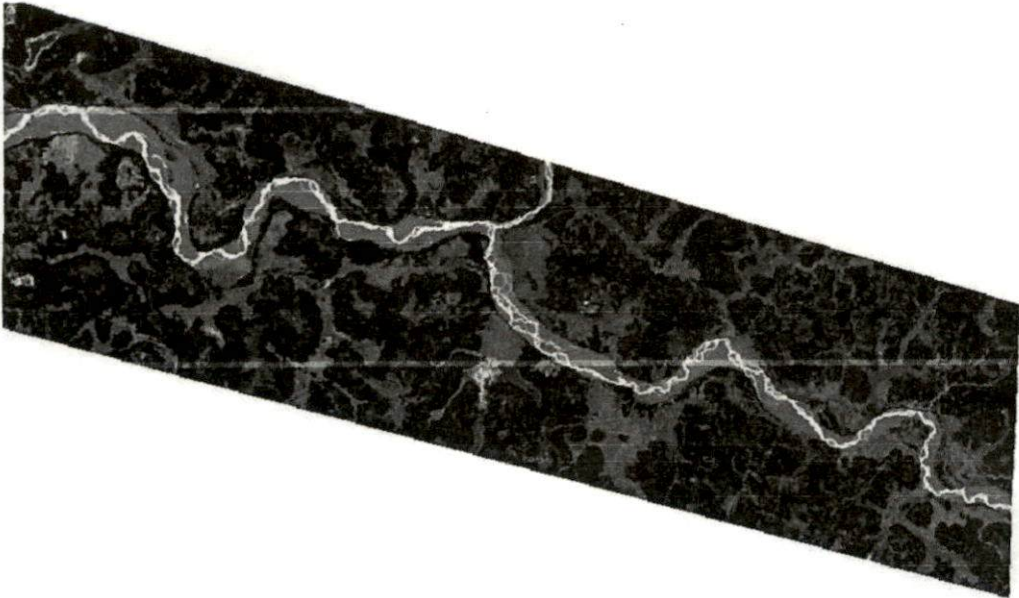
Fig. 3.21 NDWI image extracted from Landsat TM of 1990

the bands were substituted in the raster calculator and the NDWI image was created for both Landsat TM and Landsat 8 OLI imageries. NDWI images for Landsat TM (Fig. 3.21) and Landsat OLI (Fig. 3.22) was created.

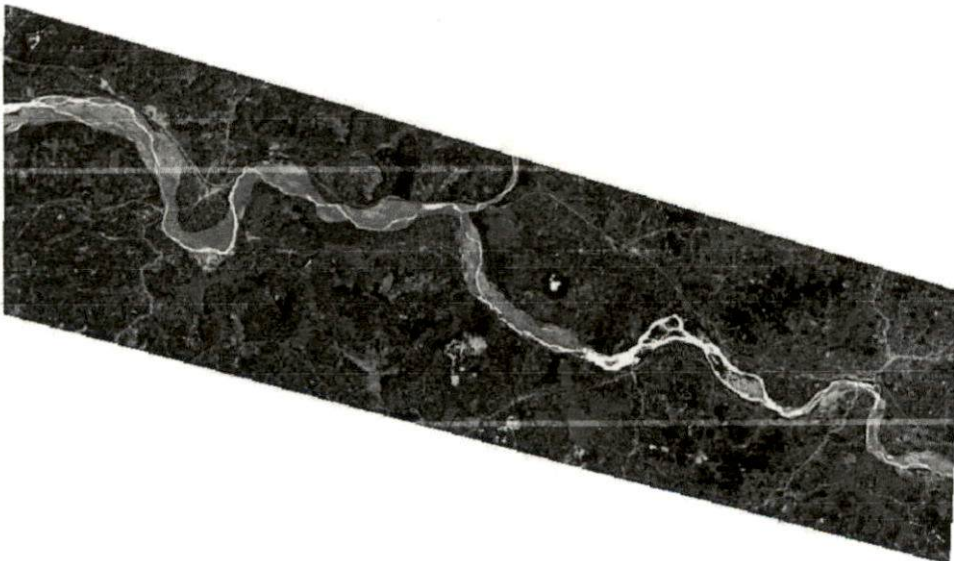
Fig. 3.22 NDWI image extracted from Landsat OLI of 2017

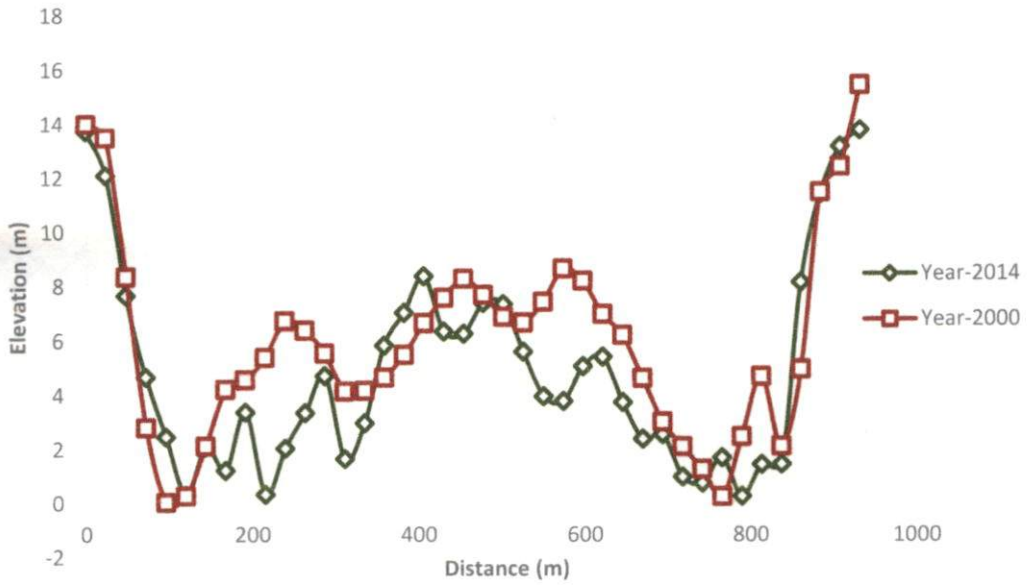
Fig. 4. 1 Cross profile of section A during 2000 and 2014

Section A located at $10^{\circ} 51' 27.2''$ N, $76^{\circ} 00' 41.7''$ E is known as Vellanchery Kadavu. This section also depicted a highly undulating cross section which describes the area with extreme rate of sand mining. The rate of downcutting was high than the rate of channel widening. The average change in depth was 1.03 m. The section observed an area change of 968.98 m^2 due to erosion. The main cause of such a large change in area was explained by the severity of sand mining in the section. This section was the wider section among all other sections. Field visit had depicted the drastic situation of the area with many depressions here and there in the channel section leaving the section unlevelled. The highest area change was also resulted in the same section. This section was considered as one of the mostly affected area due to illegal sand mining. Fig. 4.1 represents the change in depth along the section A.

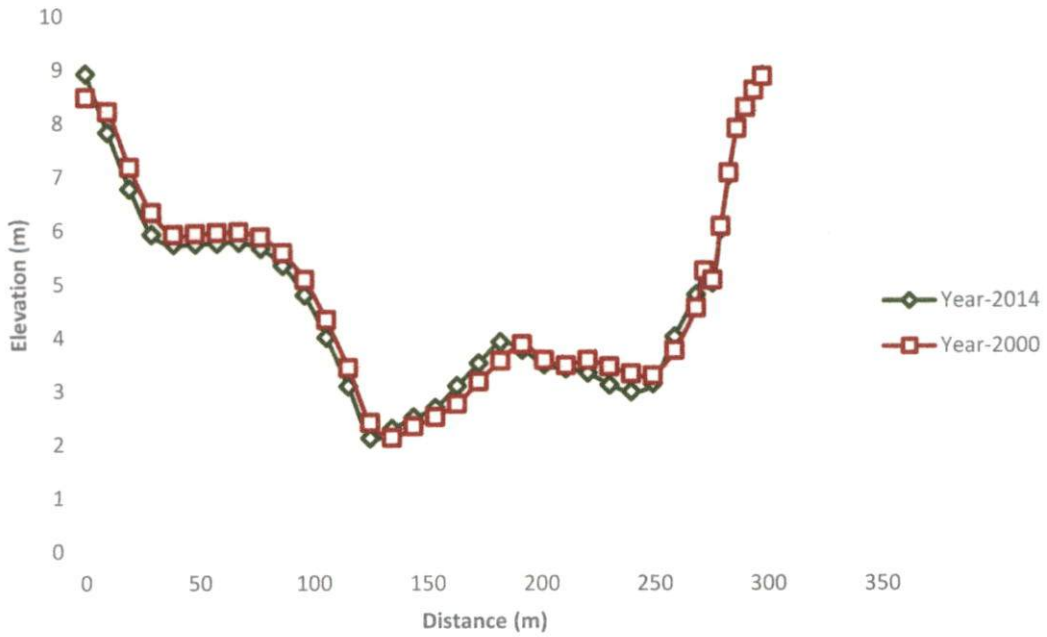
Fig. 4. 7 Cross profile of section G during 2000 and 2014

Section G located at $10^{\circ} 50' 44.4''$ N, $76^{\circ} 02' 16.0''$ E represents the School Kadavu in the field. Cross profile of the section indicated that section had undergone channel widening and scouring. The change in depth was caused due to channel scouring due to sand extraction. Channel widening was the result due to lateral erosion. The average change in depth of the section was found to be 0.07 m. Channel eroded about 27.015 m^2 . Details obtained from local people justified the reason of change was due to illegal sand mining. Fig. 4.7 represents the change in depth along the section G.

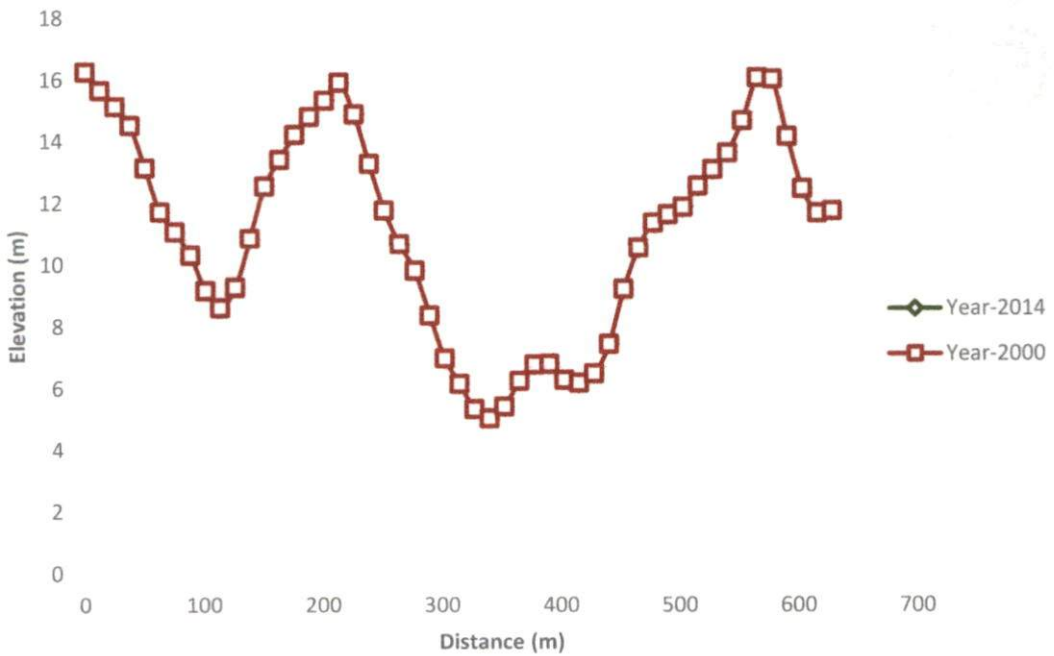
Fig. 4. 18 Cross profile of section R during 2000 and 2014

Section R is located at $76^{\circ}6'45.877''\text{E}$, $10^{\circ}48'27.833''\text{N}$. The section resulted a cross profile with no change in the elevation values during the time period 2000-2014. The section had a channel bed with varying bed slope. Small sand dunes were also seen in the middle of the channel section. The ups and downs the river channel was the result of river action and other human activities that occurred in the past. As the present cross profile denoted no change, the result depicted the river action and other human activities did not affect the channel bed severely. It can also be considered that the changes were balanced by the river itself. Fig. 4.18 represents the change in depth along the section R.
