**KERALA AGRICULTURAL UNIVERSITY  
COLLEGE OF HORTICULTURE**

**“PUNARJANI”**

**Citizens survey report**

of Wadakkanchery river, done as part of Rural  
Agricultural Work Experience Program

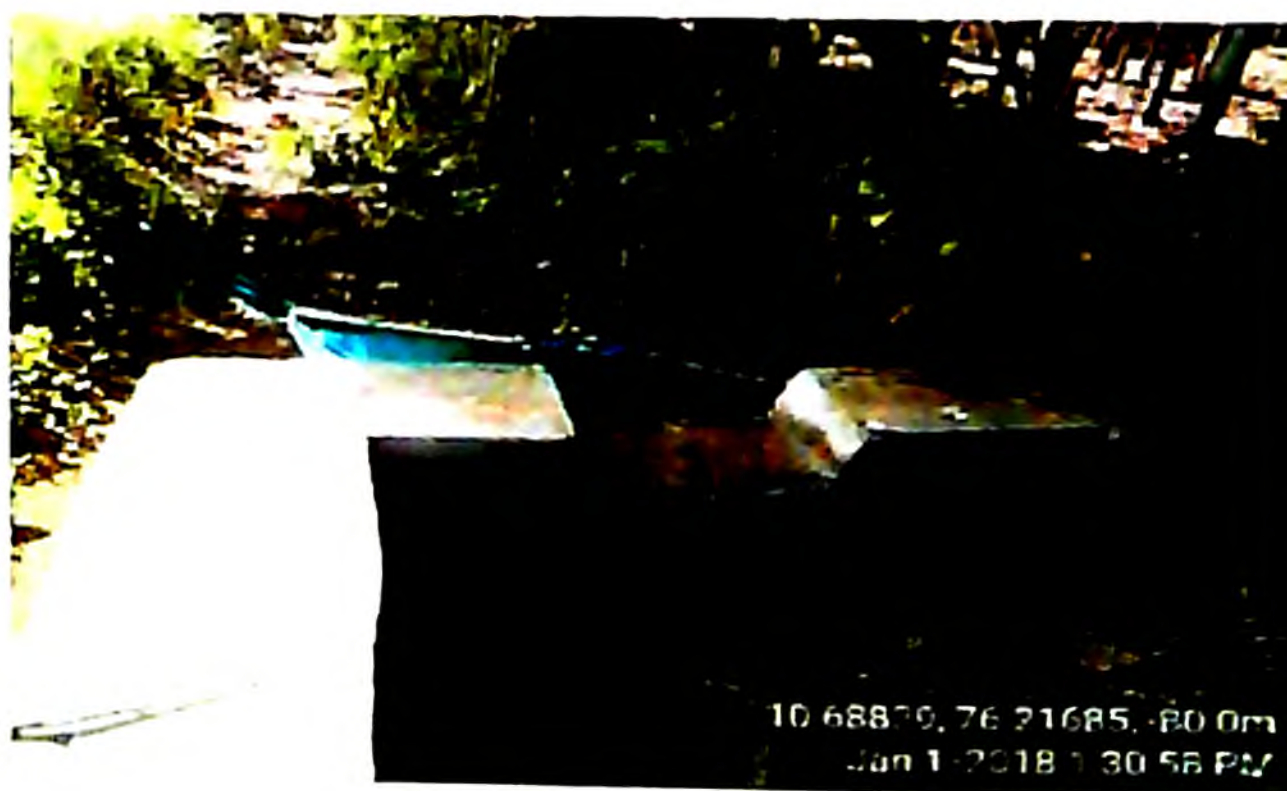
Concrete structure to control the water flow

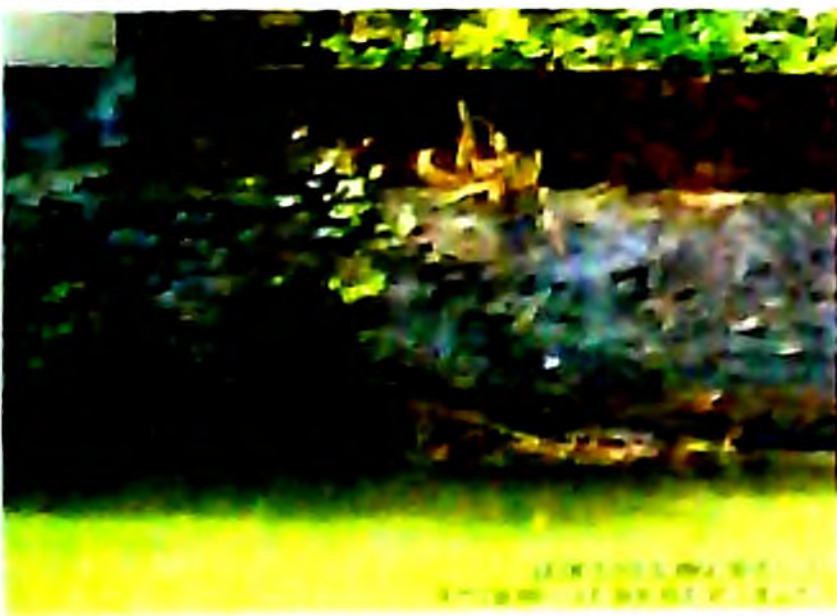
Disposal of household wastes  
through pipes

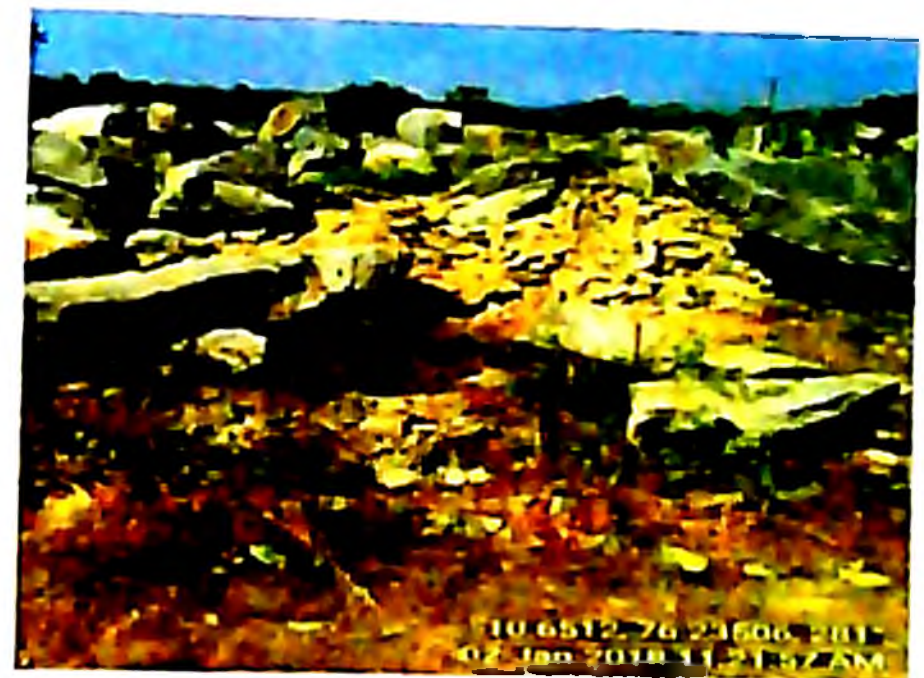
Construction Projects near the stream
