**KERALA AGRICULTURAL UNIVERSITY  
COLLEGE OF HORTICULTURE**

**“PUNARJANI”**

**Citizens survey report**

of Wadakkanchery river, done as part of Rural  
Agricultural Work Experience Program

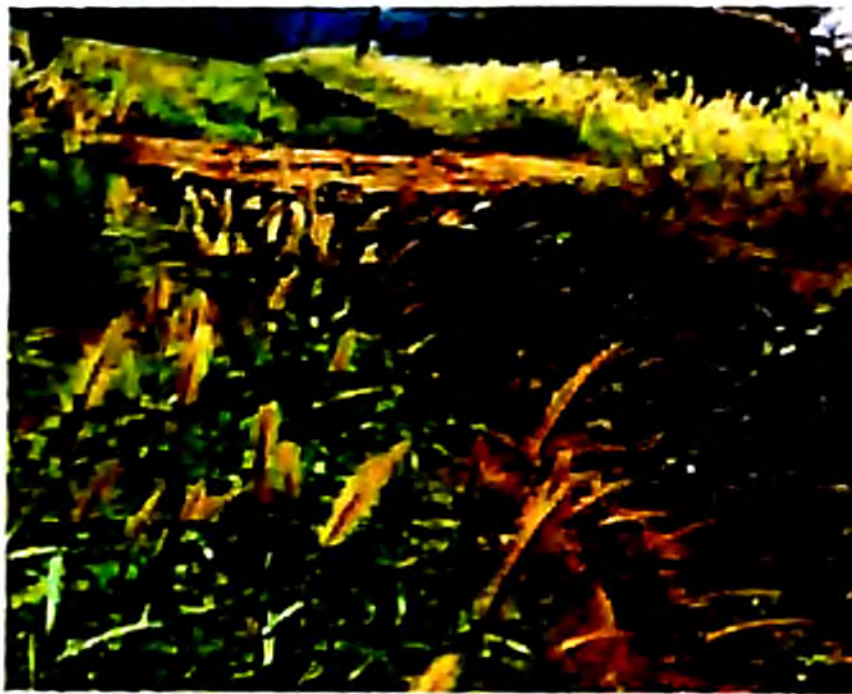
Levelled part of the stream near rice field

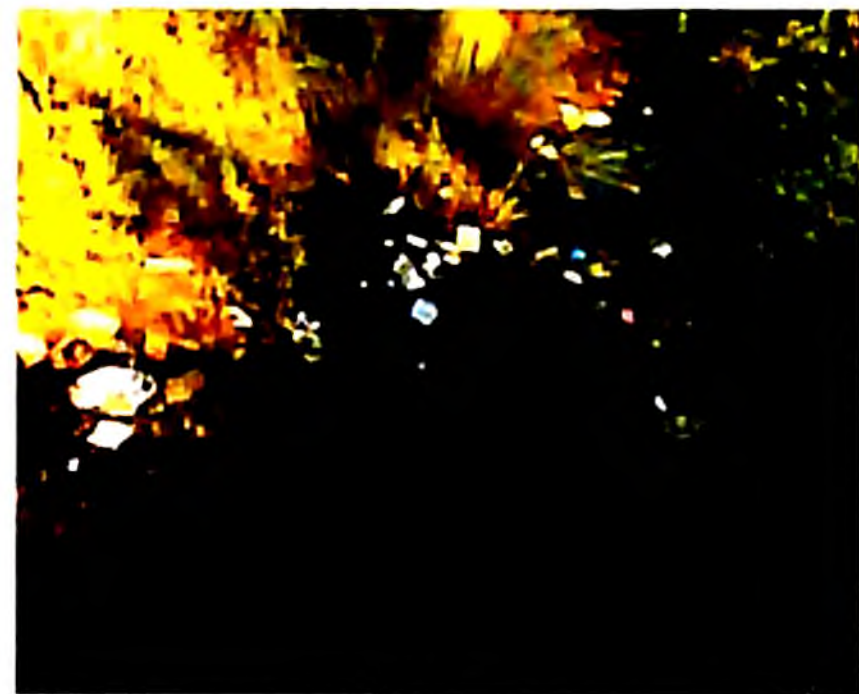
Waste disposal to the stream

- Avoid dumping of waste into streams
- Prevent encroachment of land
- Avoid conversion of streamlets into land

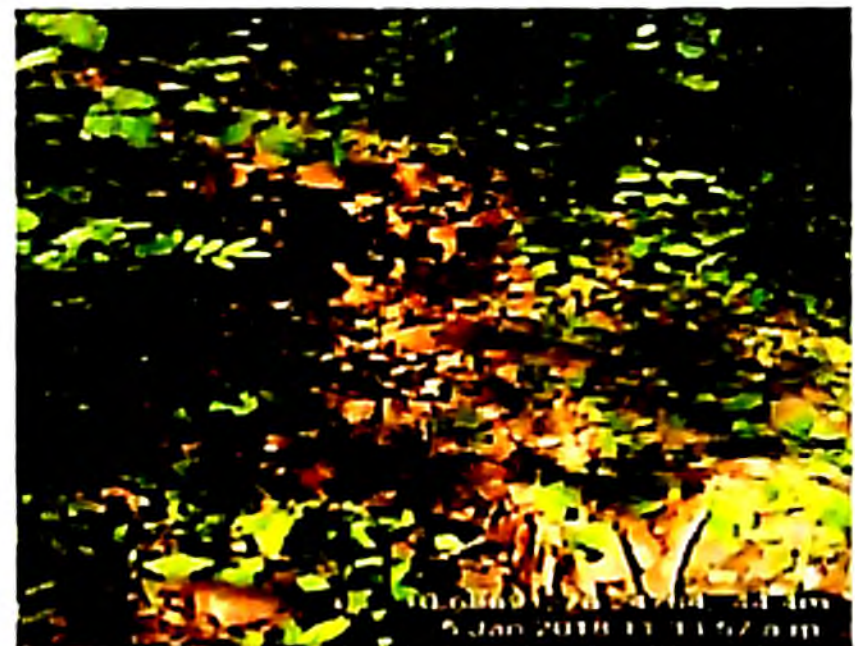
Unpolluted stream

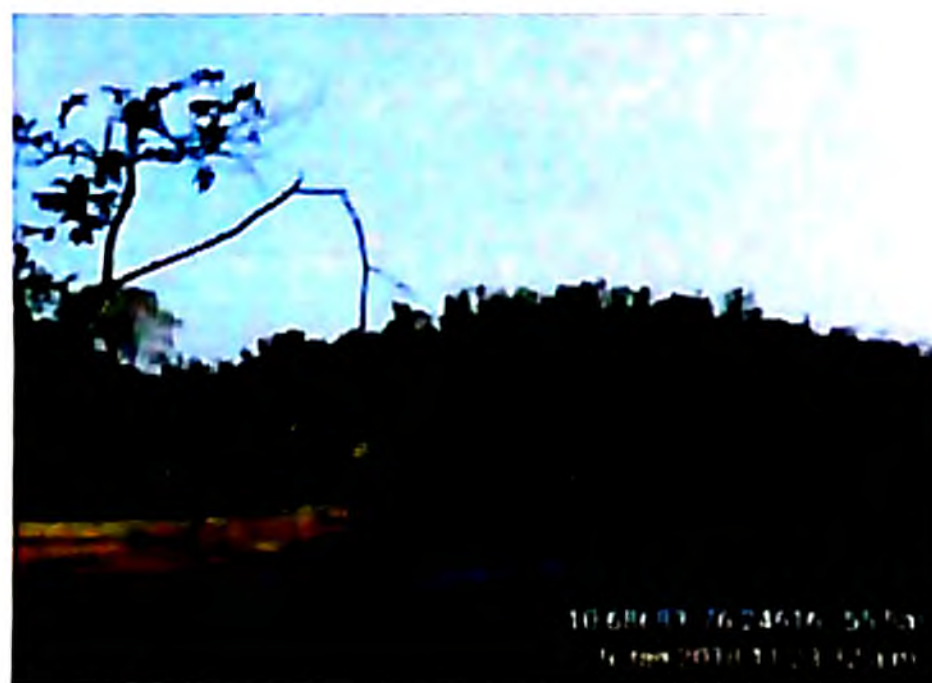
Pisciculture practiced in the stream

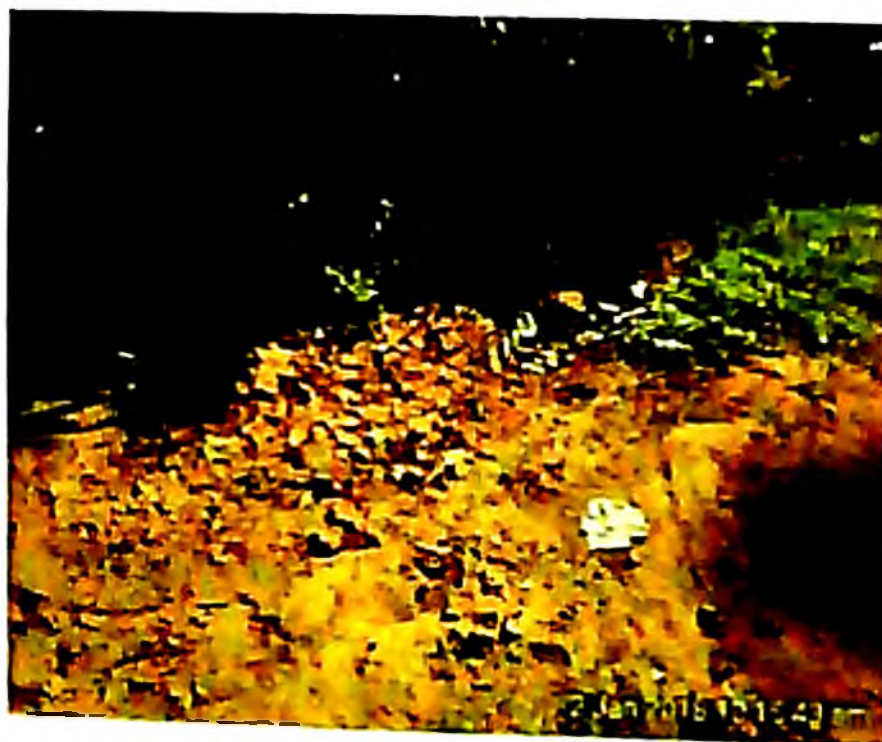
Siltation

- Measures should be taken to clean the plastic waste in stream.
- Erosion resisting plants should be planted in areas where siltation is a problem.
- Scientific construction of bunds should be recommended to conserve water.
- Water conservation measures should be taken at basic level and people should be educated on judicious use of water

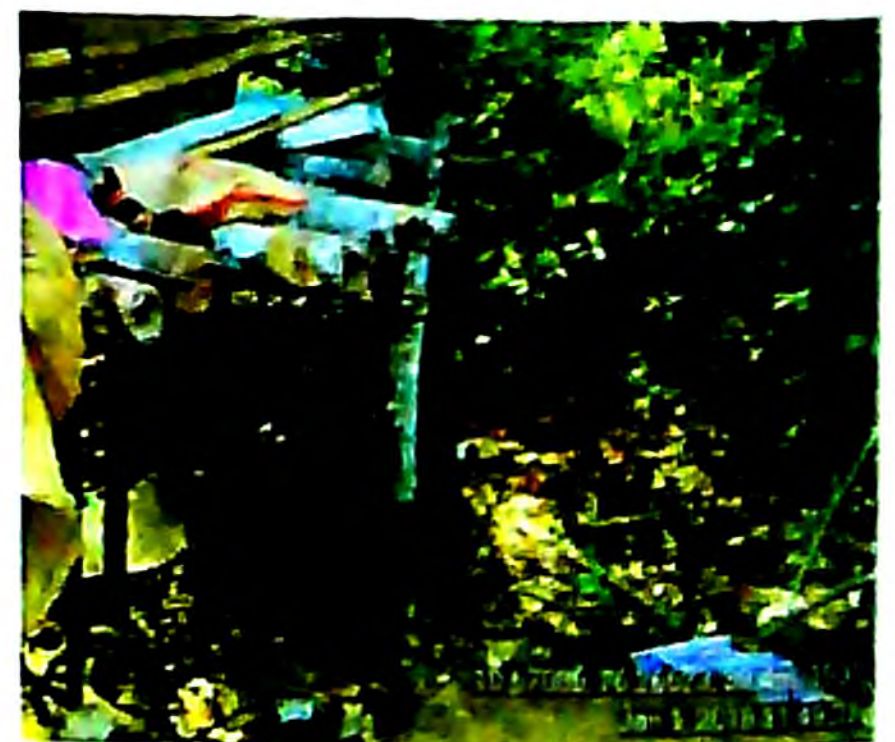
Waste dumping

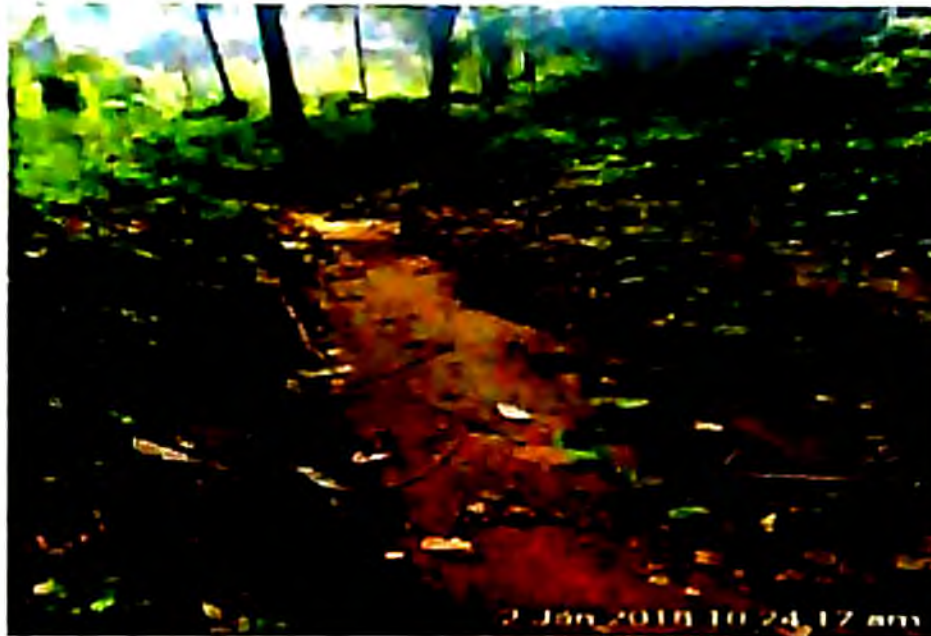
Stream without water flow

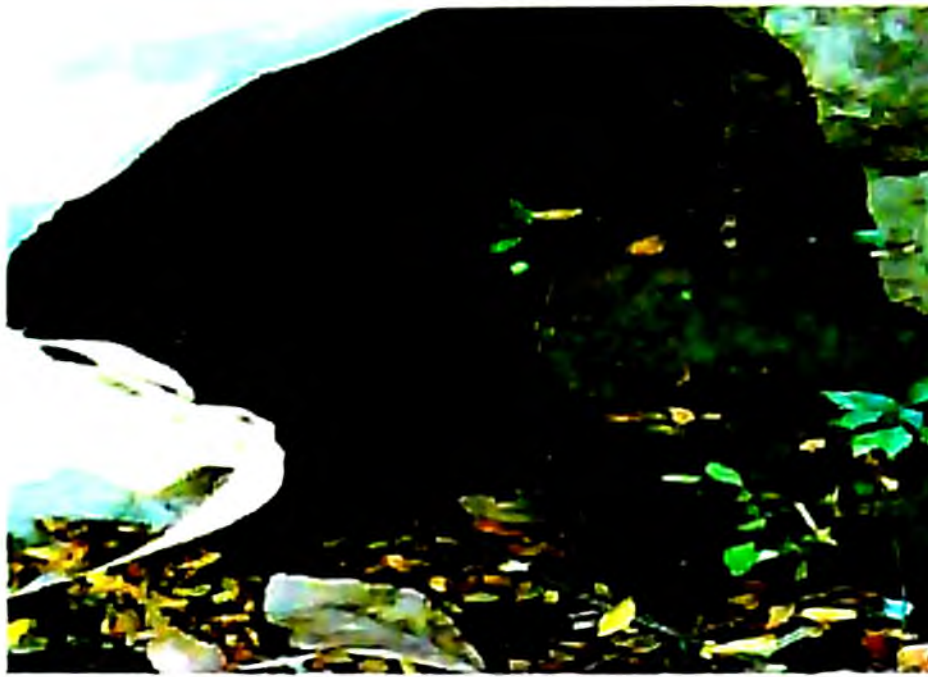
Fountain inside a rock mass

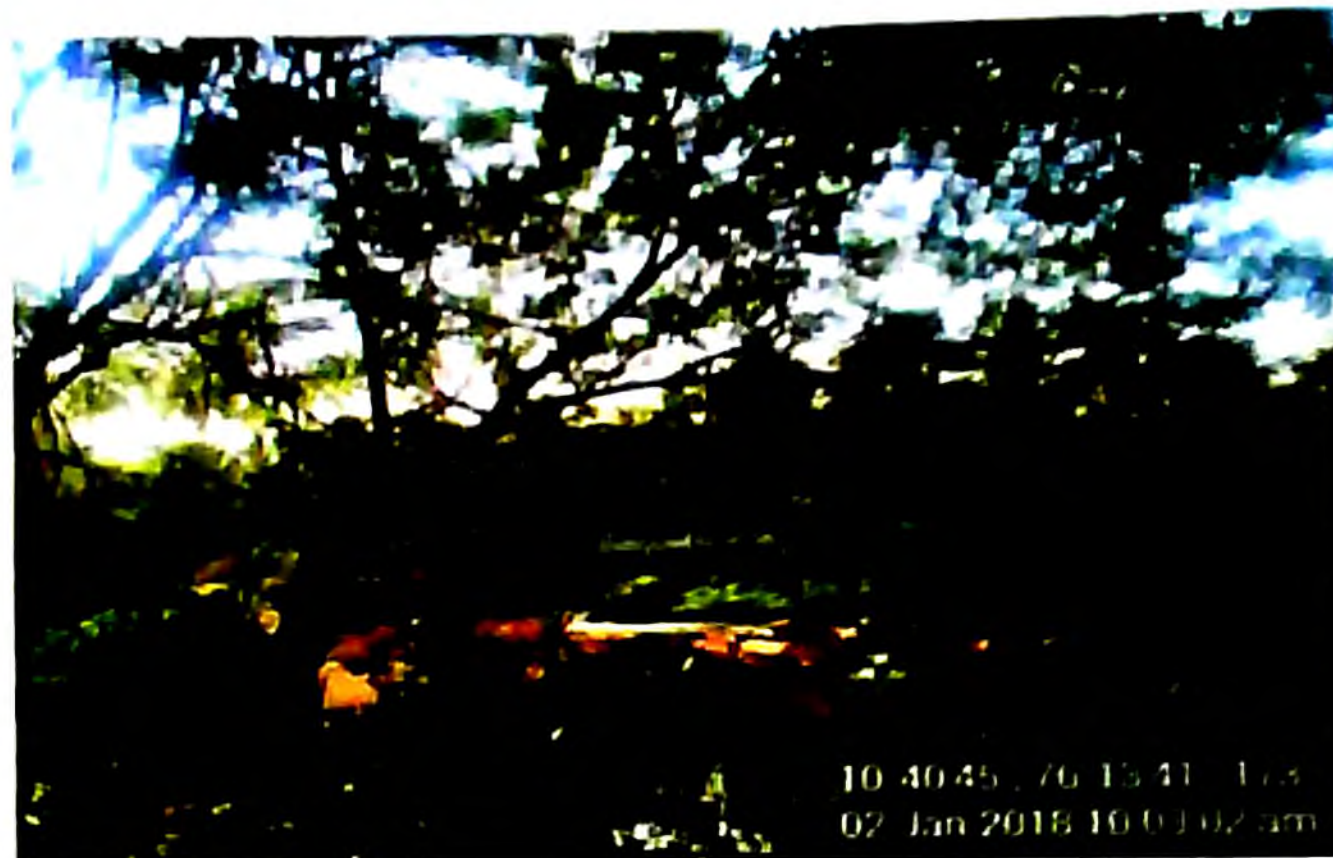
Water used for bathing and laundry

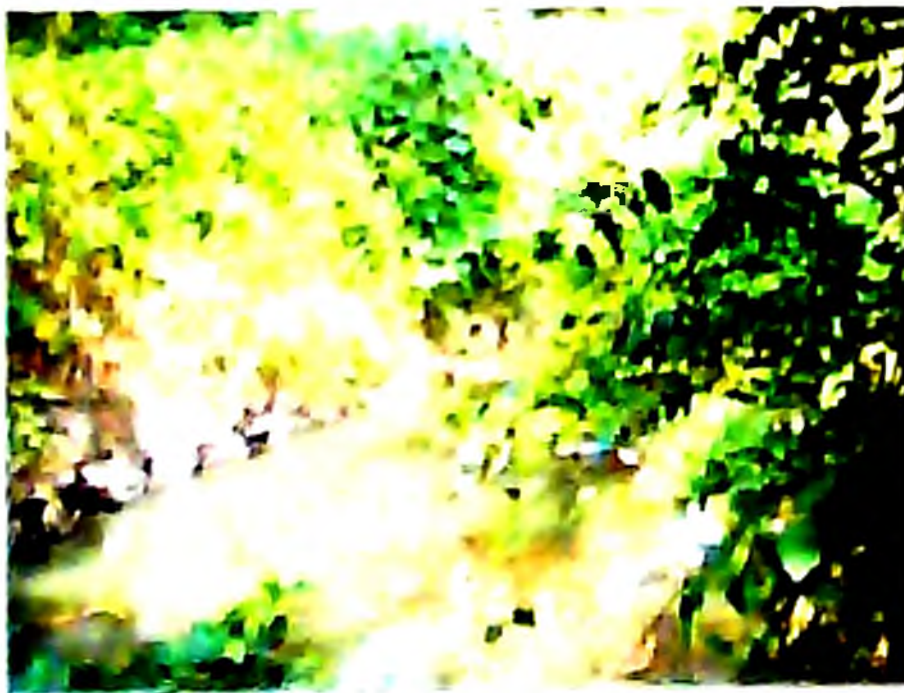
Plastic wastes

- Waste depositing into the river should be stopped .
- Plant trees in the river banks and width of the streams should be regained.
- Banks should be strengthened using geo textiles

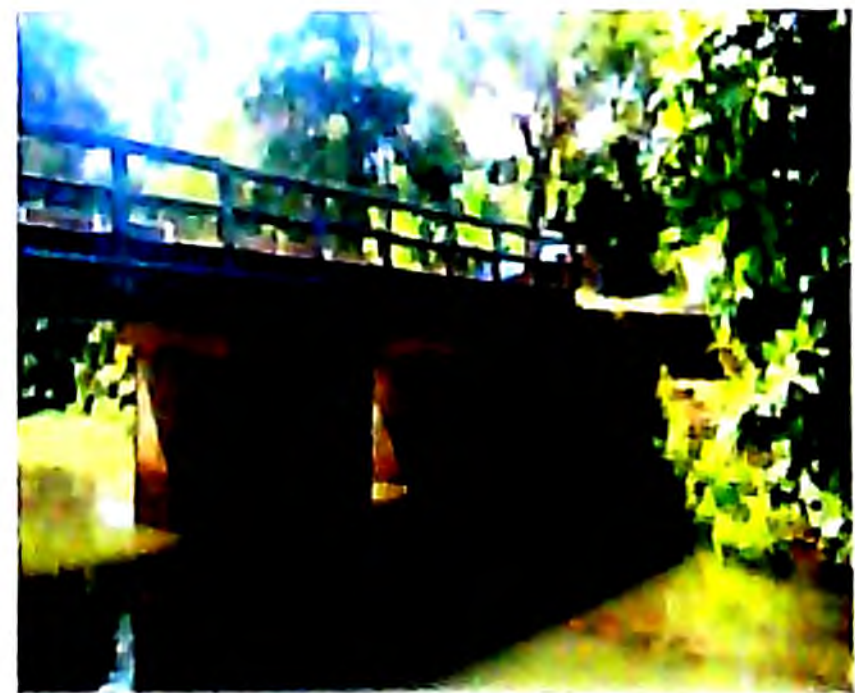
Kallankund Bridge

- One side of river basin was stone pitched due to the construction of bridge in that area.
- Opposite side was eroded and the depth of the river decreased. River water was used for cleaning purpose of clothes, other utensils and livestock animals.

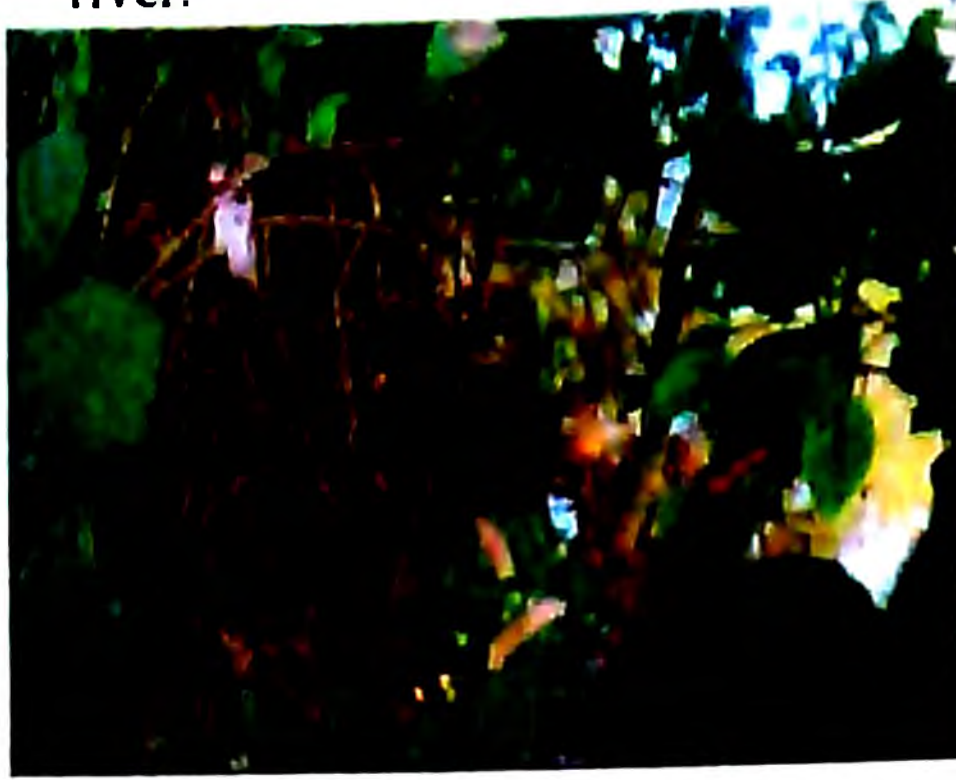
Inward flow of river

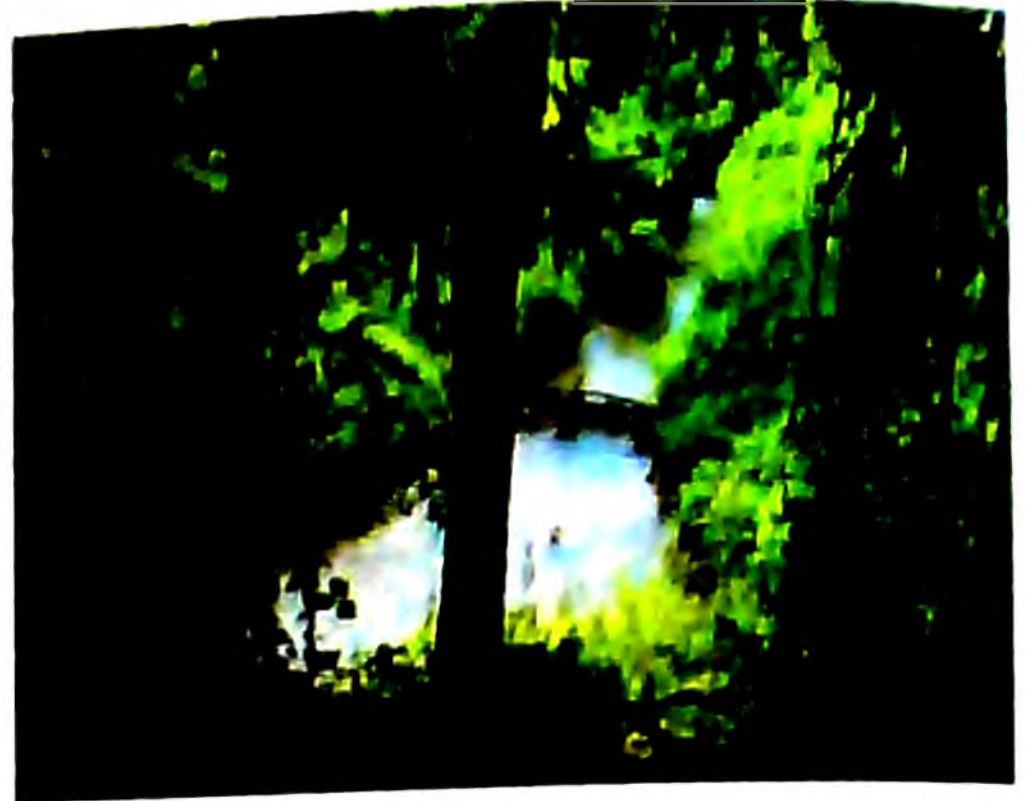
Small stream joining the river

- About 75m away from the starting point there was a small stream joining to the river. Here the river banks were eroded and the soil from the opposite bank was being pulled inwards to the river. Due to this reason, crop loss was occurring in coconut, arecanut etc.

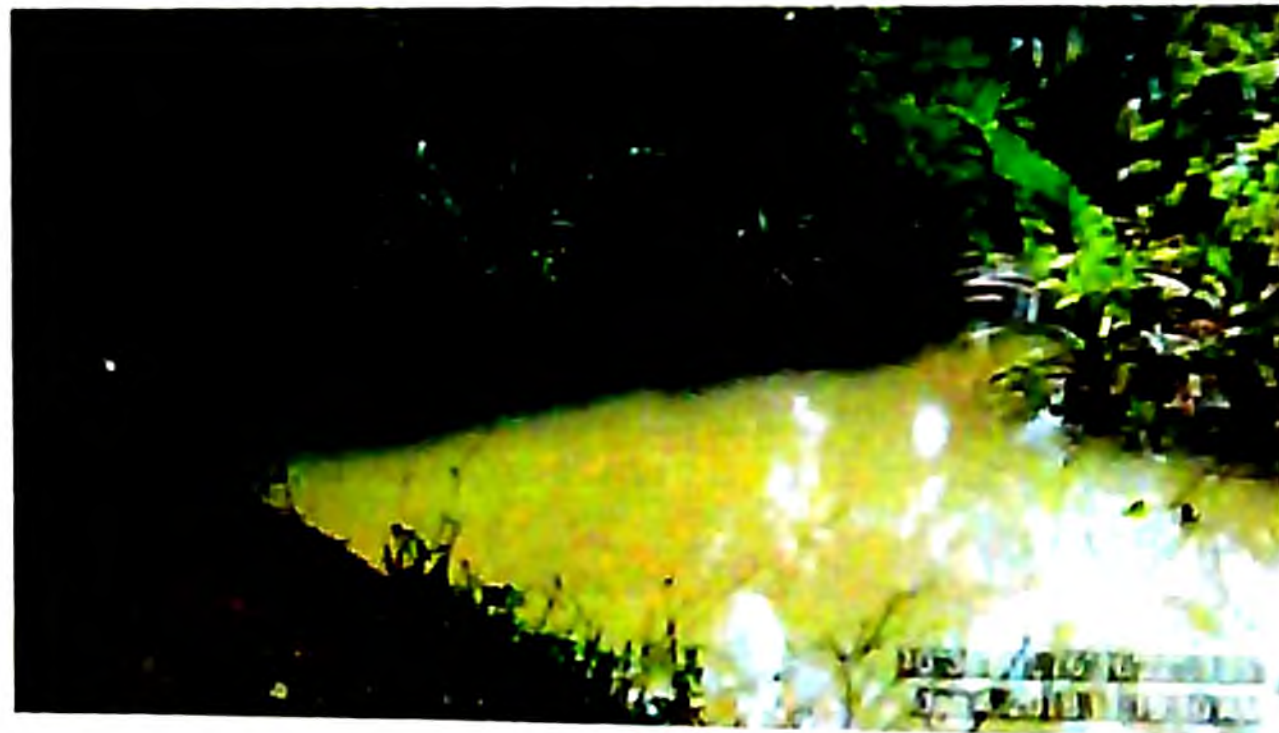
Two small streams joining the river

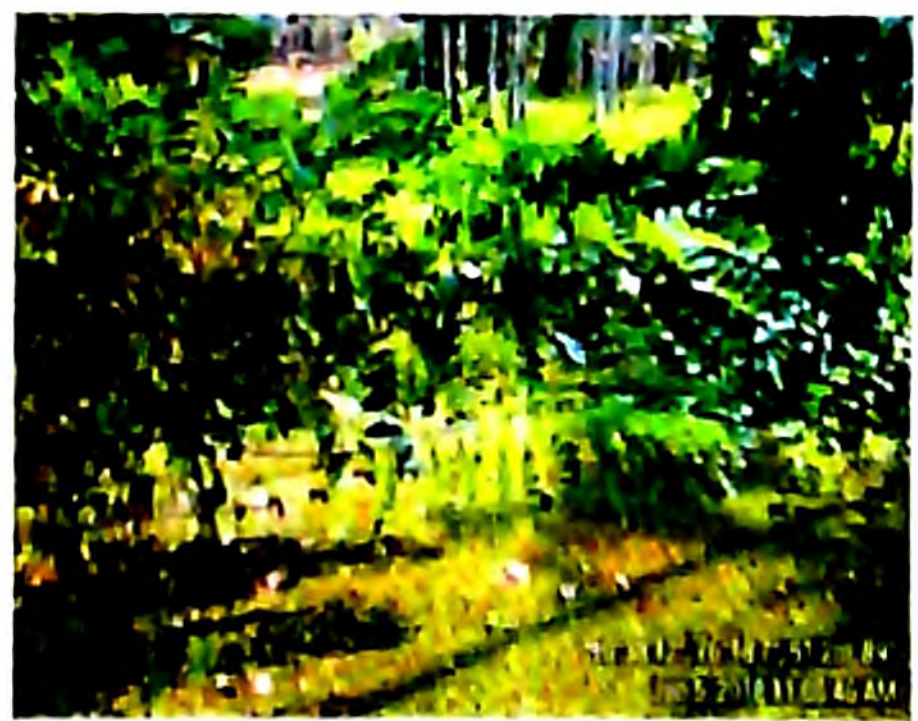
River filled with algae

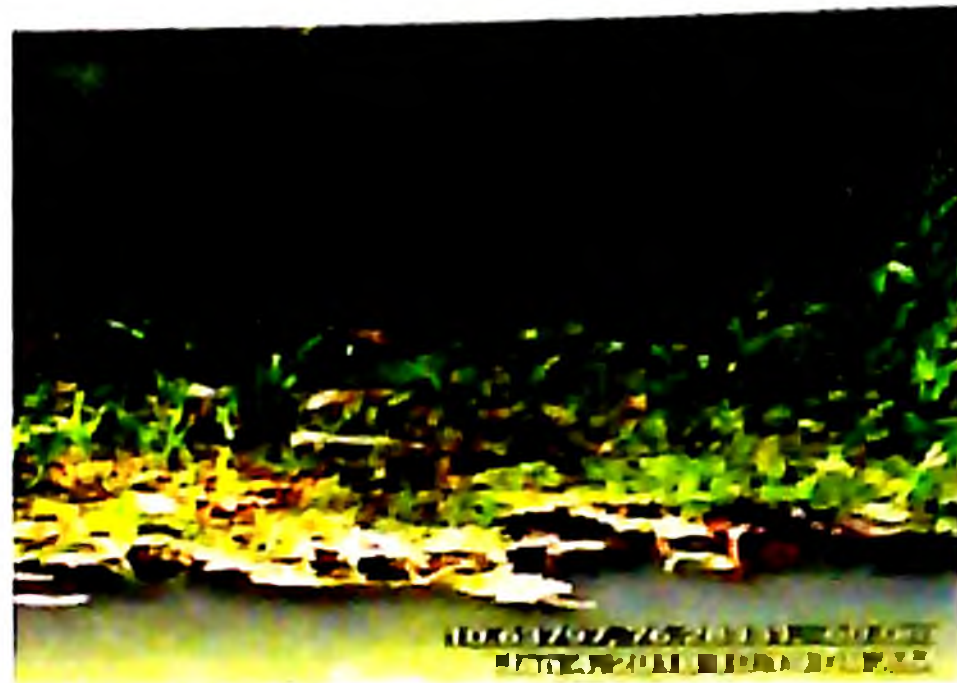
- Only some regions of the banks were concreted and the remaining were with muddy walls.
- Lots of plastic bottles and covers were there on the surface of the river

River water filled with plastic waste

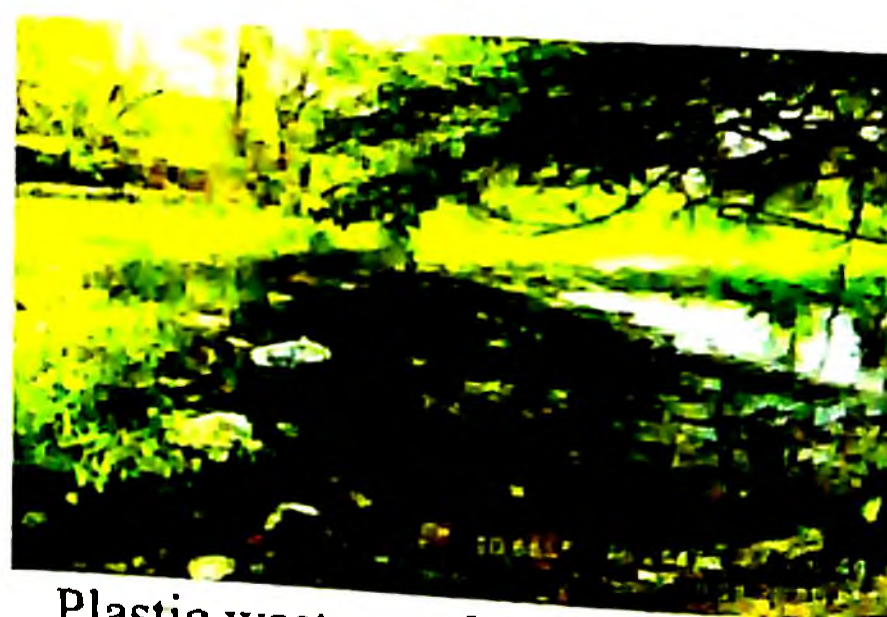
Plastic wastes and weed growth

- To protect the river panchayat should take initiative.
- Awareness generation among people.
- Growing bamboos on the sides of the river.
- Side walls with stone have to be constructed at the points of river diversion.
- Drainage channel from city should not be allowed to open into river.
- Remove the fallen trees from the river.
- Remove weeds from river.

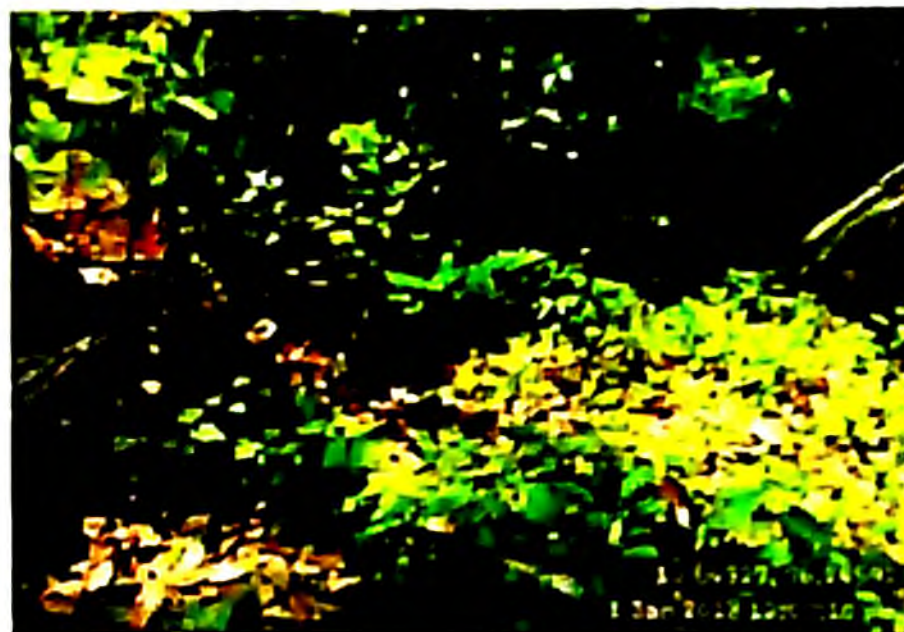
The evidences like 1m long ditches showing that there was a stream which was flowing through that area in the previous years. But now, no water flow is observed.

Markings showing the path of the stream

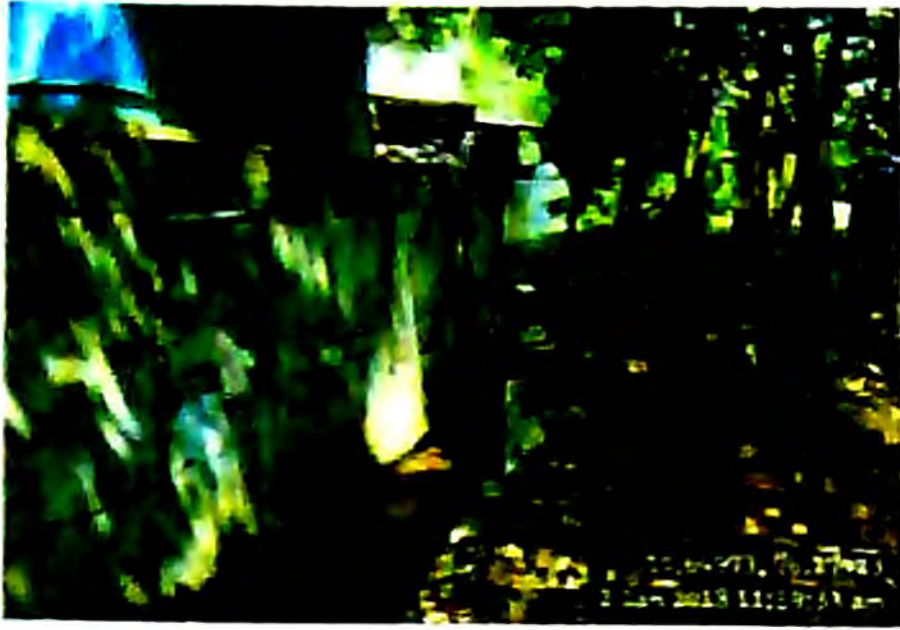
Pipelines for dumping waste

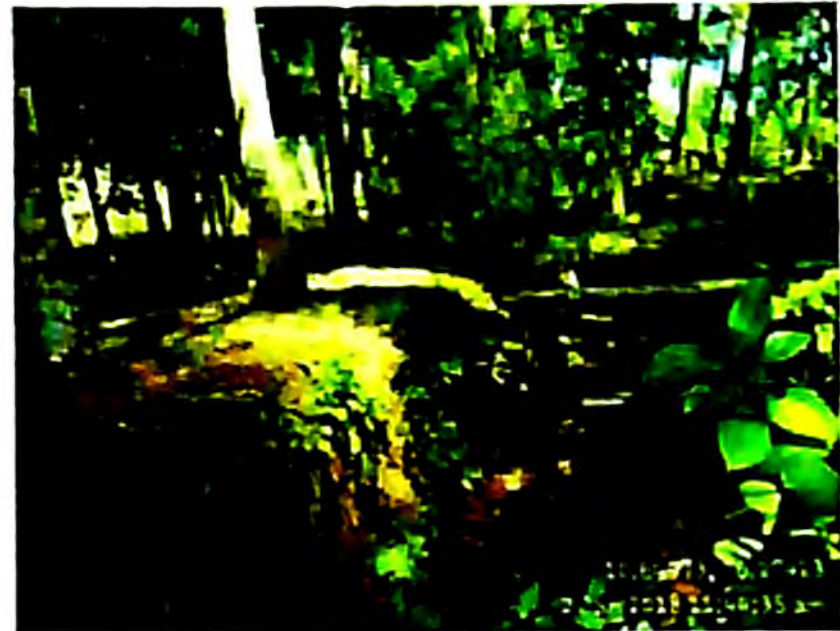
Reduced flow of water

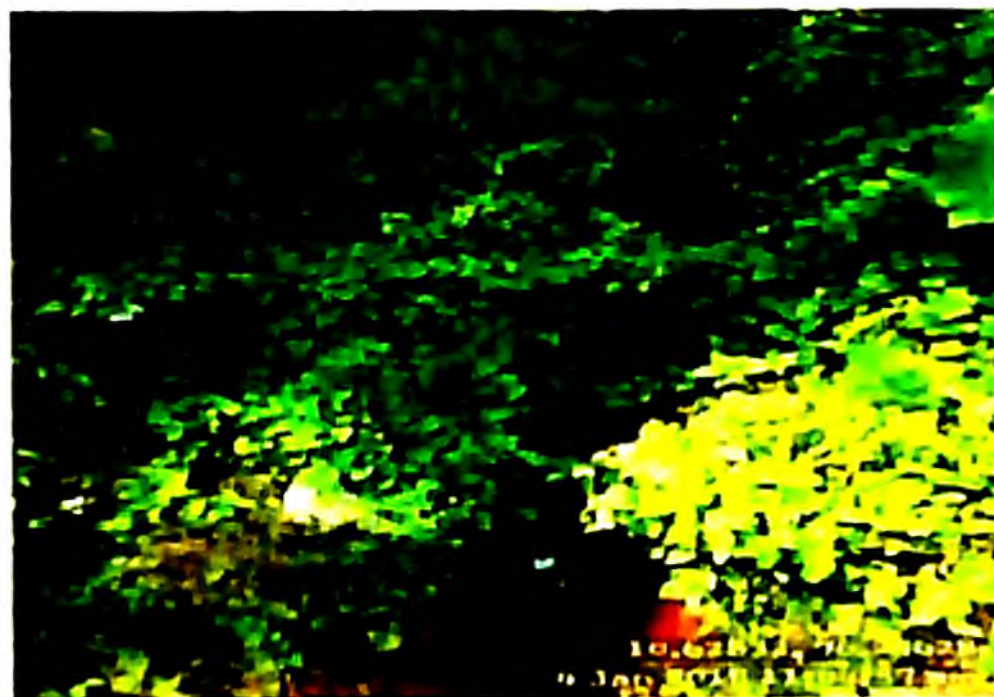
- There was not much water flow in Chilambianchola.
- The stream which was originating from the Chilambianchola loses its width in many places and the flow of water was also blocked in some areas.
- There were areas where the stream was completely dry.
- The loss water flow in the Chilambianchola was due to the presence of quarry.

Narrowed stream

- Remove the waste deposits which prevent the water flow in the stream.
- Stop waste dumping into the streams.
- Stop the quarry works which adversely affect the streams.

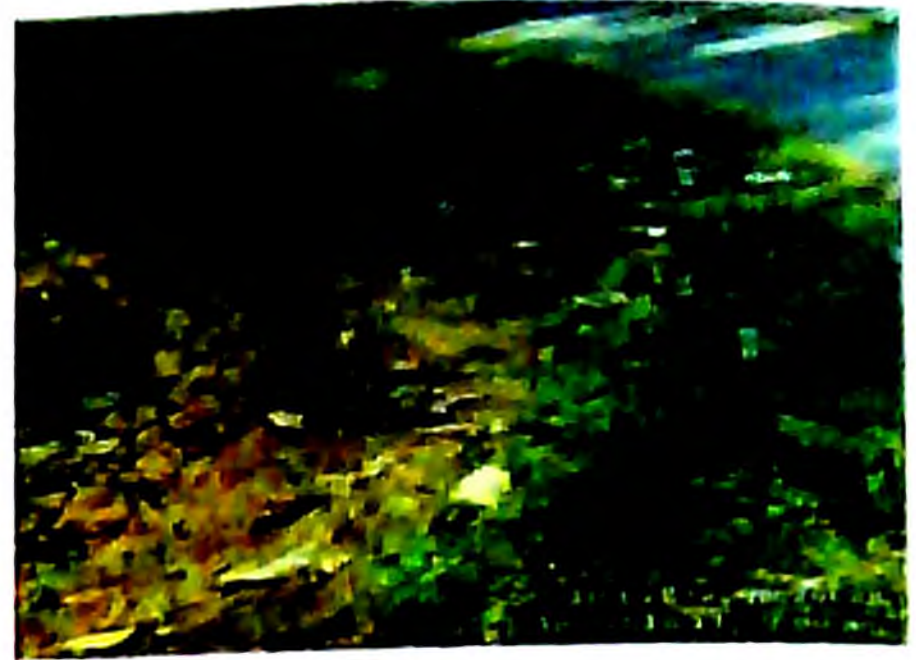
- Presently the stream was found to be completely drained.
- The domestic wastes were dumped in a large scale on both sides of the road.
- The wastes will reach into the stream during rain and get deposited due to poor water flow.
- The stream flows through Koovakkadu- Pallikkadu road and finally reaches to Kecheri river after joining with Planithodu and Neclarathodu.

Drained canal

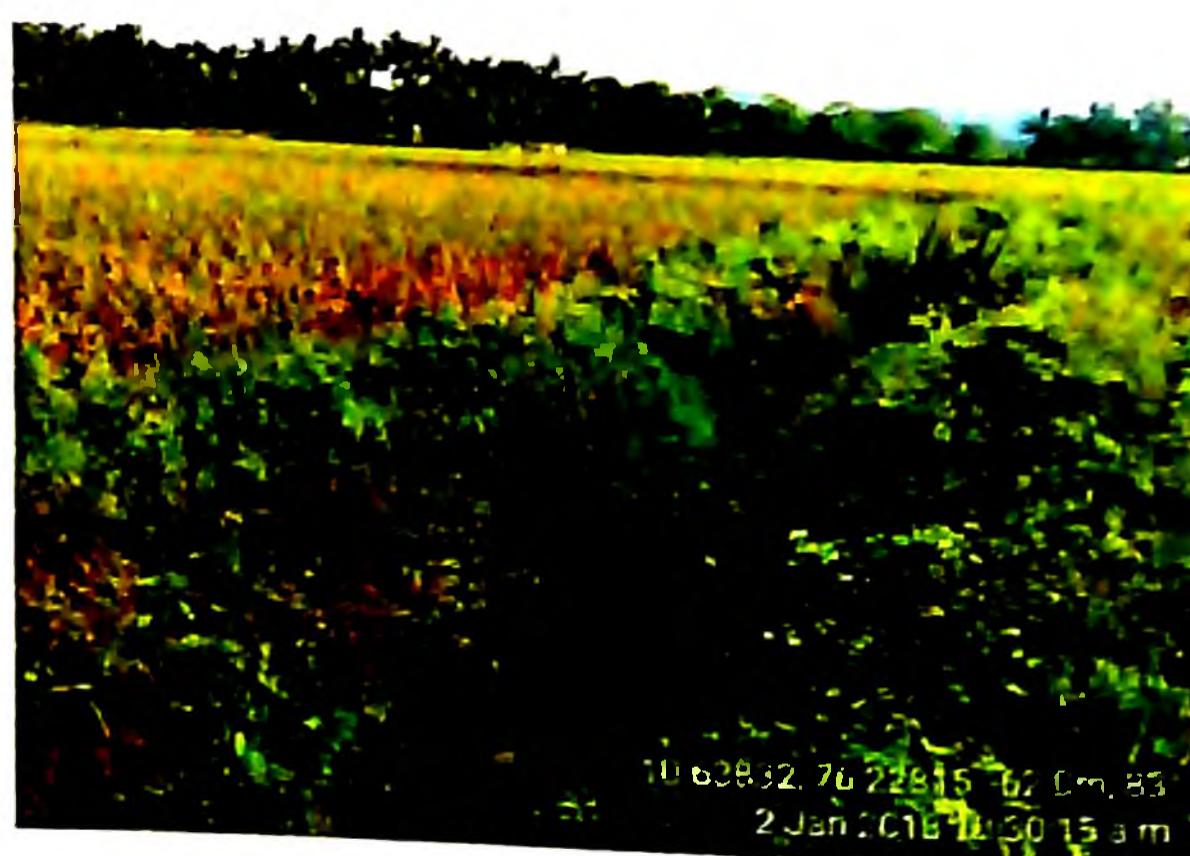
Stream flows through the paddy fields

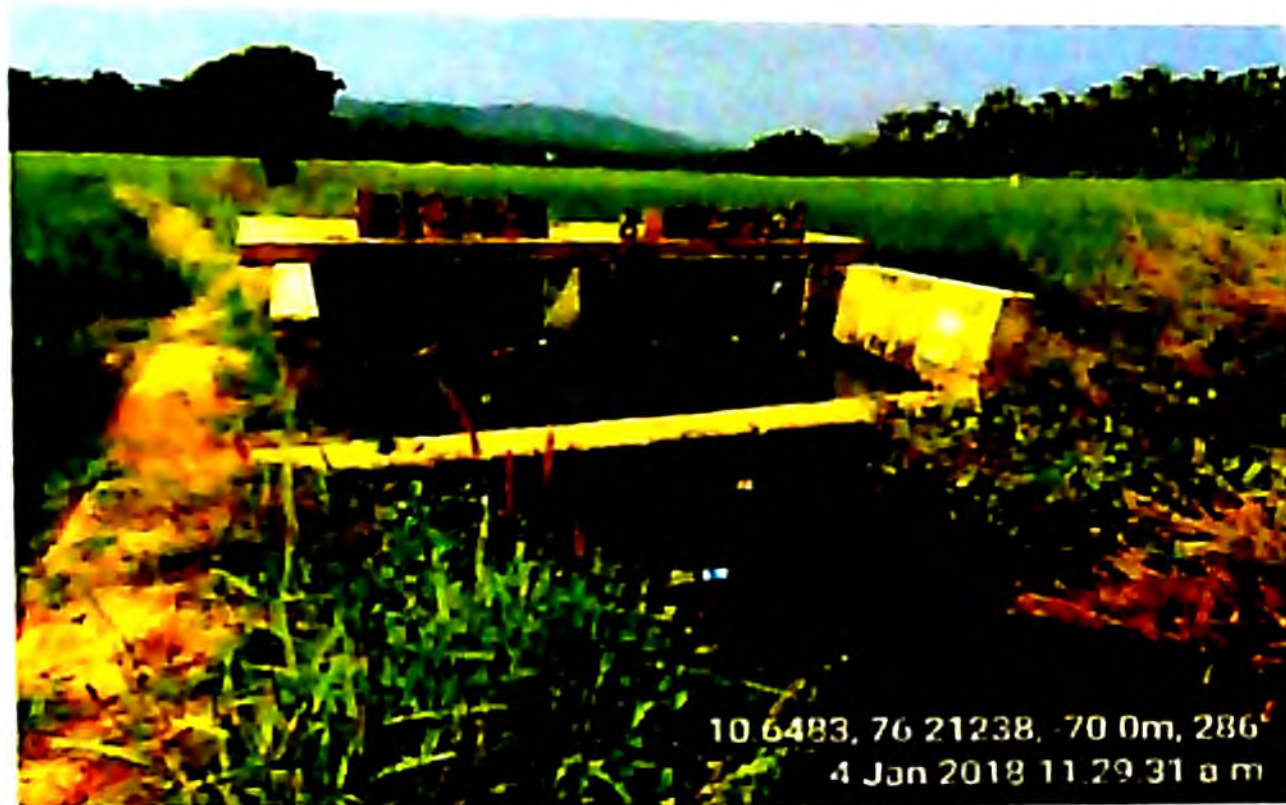
The stream deviated and joined to another one

- Protect the side walls.
- Take measures to keep the natural flow of water in the stream.

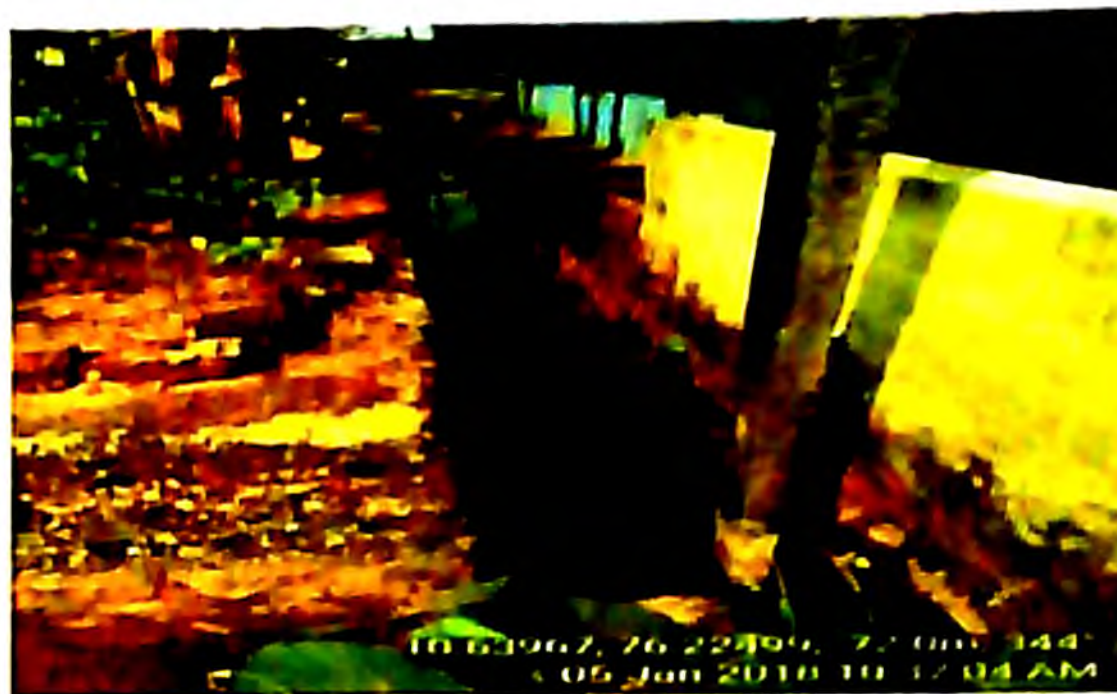
Stream flowing beside a private residence.

**Sujith:** The stream was having a better width in older times. The damages on the walls separating field from stream caused the reduction in width.

- Prevent the garbage depositing into the stream.
- Grow small plants on the sides of in place of the cement walls.
- Protect the ponds near the stream.
- Prevent privatization of stream premises.

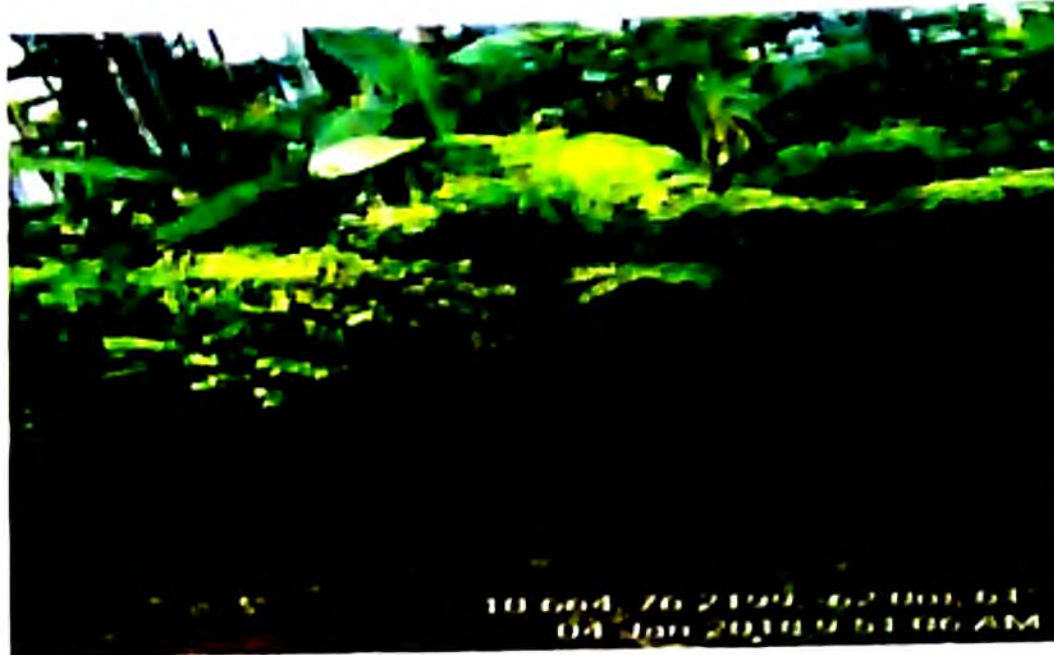
Live fencing using Glyricidia
